Coal Operators' Conference

Coal Bumps in an Eastern Kentucky USA Longwall Coal Mine 1989 to 1997

COAL BUMPS IN AN EASTERN KENTUCKY USA LONGWALL COAL MINE 1989 TO 1997

John Hoelle¹

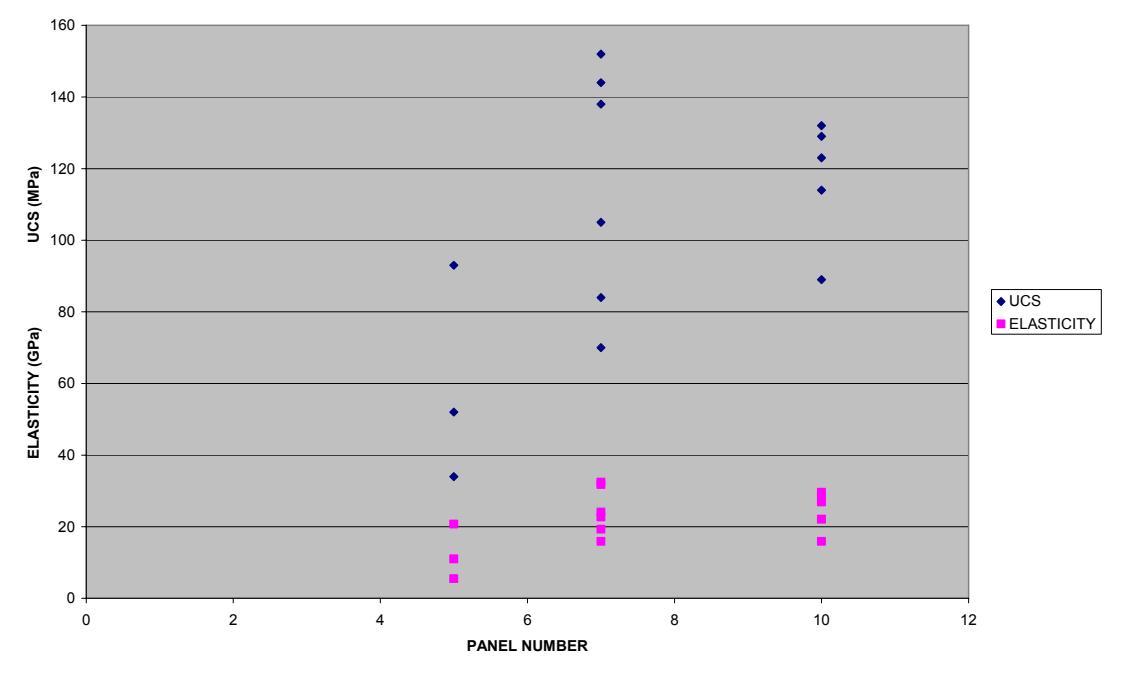
Figure 3 - Profile of gateroad

Starting with the panel 3 headgate, core holes were drilled 2.5 to 3.0 m into the floor and 12 to 15 m into the roof from the gate roads. The purpose of this was to determine if thick sandstone roof strata was present. A strong sandstone on or near the coal was not encountered; however a strong siltstone did occur within 0.6 m of the coal seam. A typical profile from the drilling is shown in Figure 3. Along with strata identification, RQD's were recorded and starting with the fifth panel, samples were tested for UCS and Young's modulus strength characteristics. The test results are illustrated in Table 3. The UCS strengths and the Young's modulus increased from south to north and from west to east. Figure 4 illustrates the increase in UCS and Young's modulus. The first five panels were bump-free even though the overburden thicknesses were up to 670 m. Because the first five panels were bump free, it was decided that the abutment pillars were properly designed to prevent bumps from occurring.
