An approach to addressing explosive related accidents by implementing strategic training

Gour Sen
University of Wollongong, gour@uow.edu.au

G. Downs
Department of Mines and Energy, Queensland

AN APPROACH TO ADDRESSING EXPLOSIVE RELATED ACCIDENTS BY IMPLEMENTING STRATEGIC TRAINING

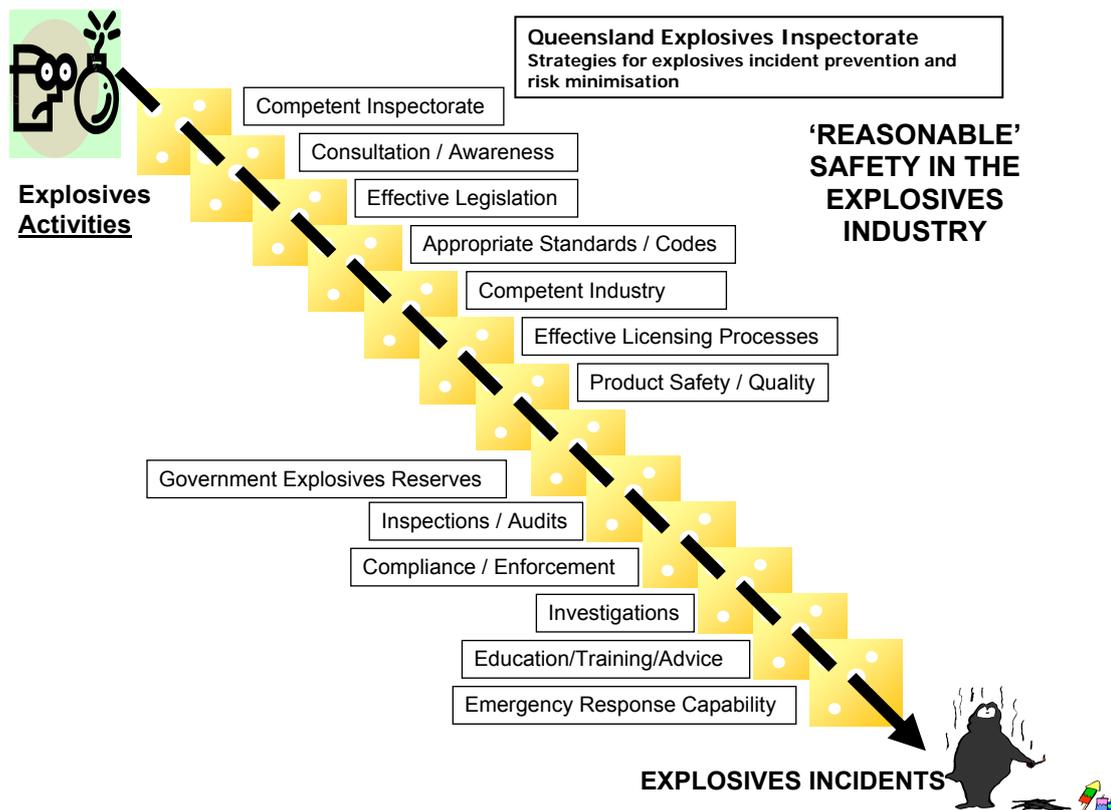
The approach of the Explosives Inspectorate is based on the approach of Professor James Reason and the Swiss Cheese Model and is summarised in Figure 1.

Figure 1 - Queensland Explosives Inspectorate Strategies for explosives incident prevention and risk minimisation

Briefly, in the "Swiss Cheese" model, a series of barriers and defences are put in place to prevent incidents. Each barrier and defence is not entirely 100% effective and hence there is an opening in that barrier and defence and hence the hole. The hole may open and close due to the changing circumstances altering its effectiveness. The more barriers and defences that are effective are put in place, the more reliable and effective the strategy and system will be. When the holes in the "Swiss Cheese" line up, an incident will occur.

From Figure 1, a competent industry together with suitable education and training are important barriers and defences in the strategy to prevent explosives incidents and minimise risk. Effective training and competencies are
