# Innovative Approach to Maintaining Mine Ventilation During Fan Upgrade at Carborough Downs Mine, June 2008

O. Morgan  
*Carborough Downs Mine*

M. Watkinson  
*Vale Australia*

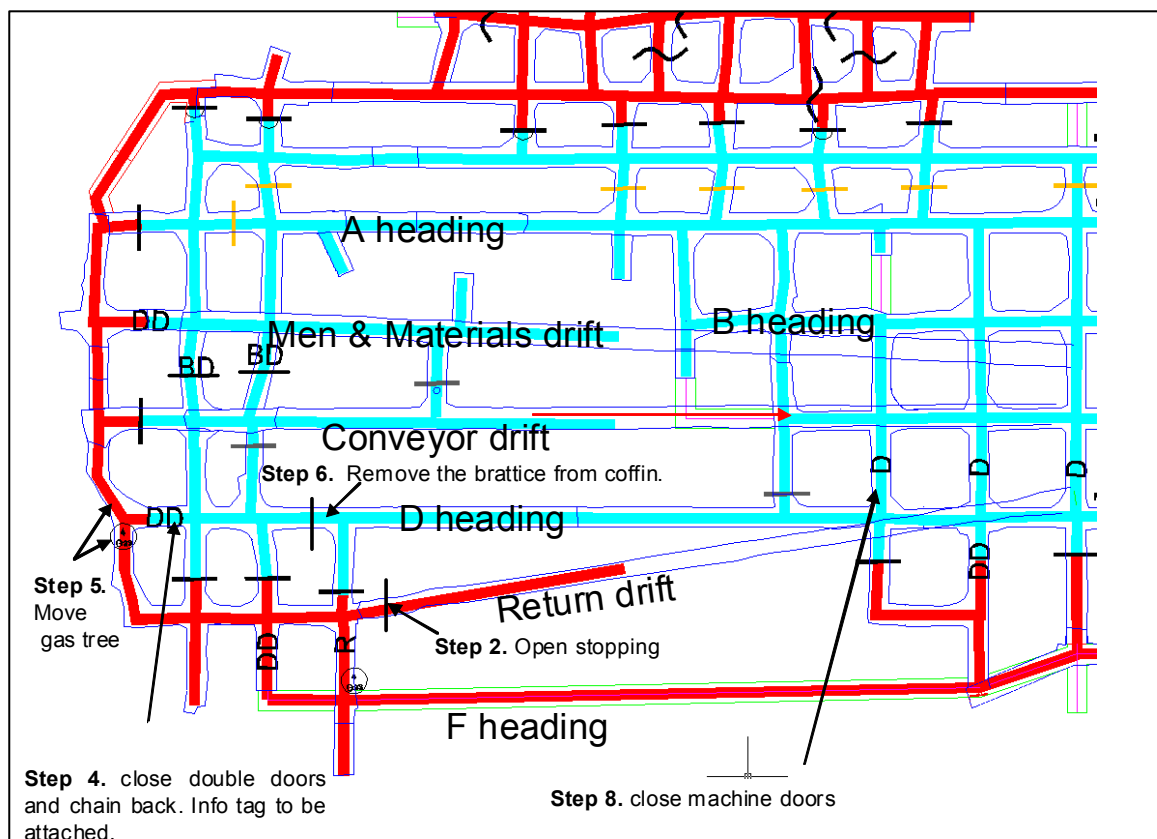
Figure 3 - Plan showing changes for recommissioning of the upgraded fans

mains panel at the time and steps were taken to recover the loader using a temporary ventilation change. In order to recover the loader the tailgate panel was closed off to increase the quantities to the east mains return and therefore reduce the general body concentrations in the return where the loader was located to below 1%. This change worked well although it created another problem as by the time the loader had been removed from the return and the tailgate ventilation was being restored it had given the methane (0.25%) in a stub located 5 m inbye of the ERZ/NERZ boundary sensor in the tailgate time to reach the sensor location with the lack of ventilation in the area. This tripped underground power. The fans that were being used to ventilate the mine during this shutdown were being powered from the 1050 volt tramping outlet on the side of the main fan switch room. This was connected to underground power and therefore tripped off the fans. The ventilation in the mine was only lost for twenty minutes but the delay was then in re-powering the mine. The whole loader recovery, that had only interrupted the tailgate ventilation for a period of 15 minutes, caused nearly two hours delay to the power in the panels. The upgraded mine fans were re-started as detailed in the procedure below and identified in Figure 3.
