# Roadway Span Stability in Thick Seam Mining - Field Monitoring and Numerical Investigation at Moranbah North Mine

# ROADWAY SPAN STABILITY IN THICK SEAM MINING - FIELD MONITORING AND NUMERICAL INVESTIGATION AT MORANBAH NORTH MINE

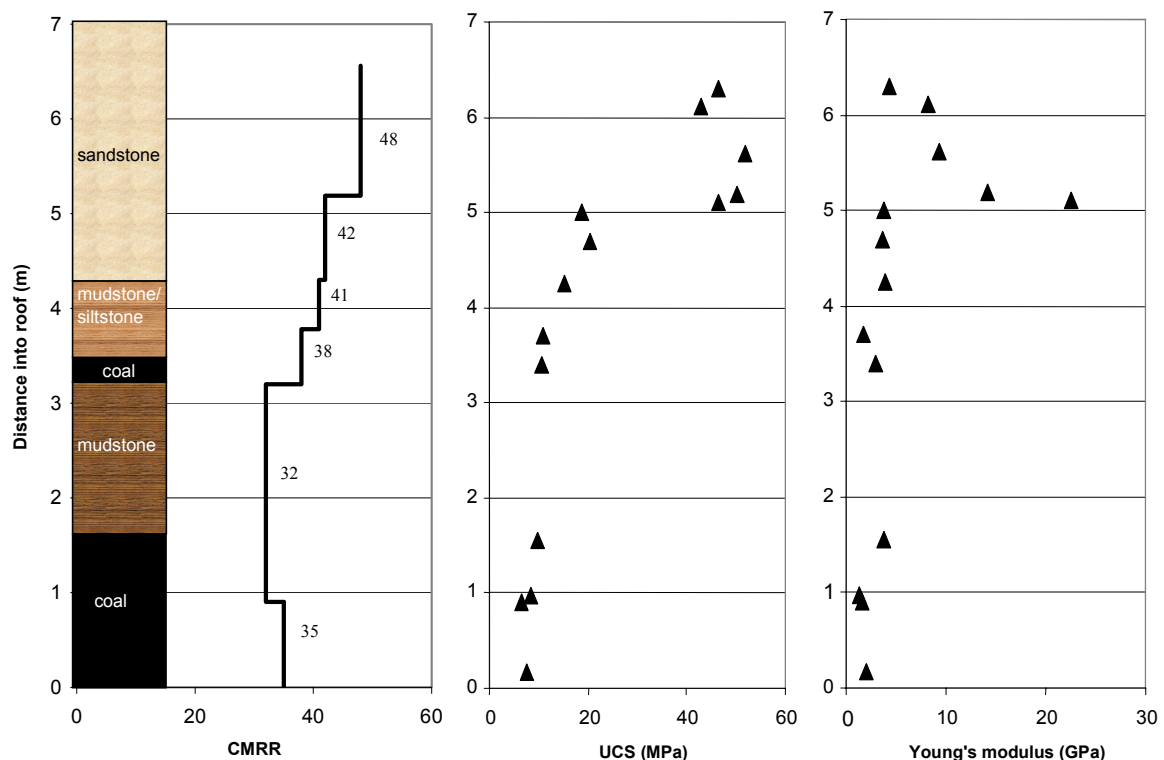
FIG. 1 - Roof geology, CMRR, rock strength and Young's modulus in the monitored holes

The geology from the drill holes is generally consistent. The typical roof geology in the monitored area is shown in Figure 1. The immediate roof is 1.7m coal. It is of C3 type (40-60% bright) immediately above the roof and becomes dull coal with bright bands at the top of the seam. Overlying the coal seam is a weak to very weak mudstone unit. The mudstone unit has a thickness of about 1.8m. Above this unit is the Goonyella Rider Seam (GMR) which has an average thickness of 0.2m. Above the GMR unit is a sequence of mudstone/siltstone/sandstone units.

Also shown in Figure 1 is the Coal Mine Roof Rating (CMRR) for different roof units. The roof coal and the mudstone units have a CMRR value  $\leq 35$  (Figure 1). According to Mark (1999), unsupported roadway spans with a CMRR less than 46 are considered to be unstable in the long term.

Fourteen coal and rock samples selected from the roof cores were tested in uniaxial compression to determine the strength and deformability (Cunnington and Boland, 2002). The tested Uniaxial Compressive Strength (UCS) and Young's modulus (E) are also plotted in Figure 1.

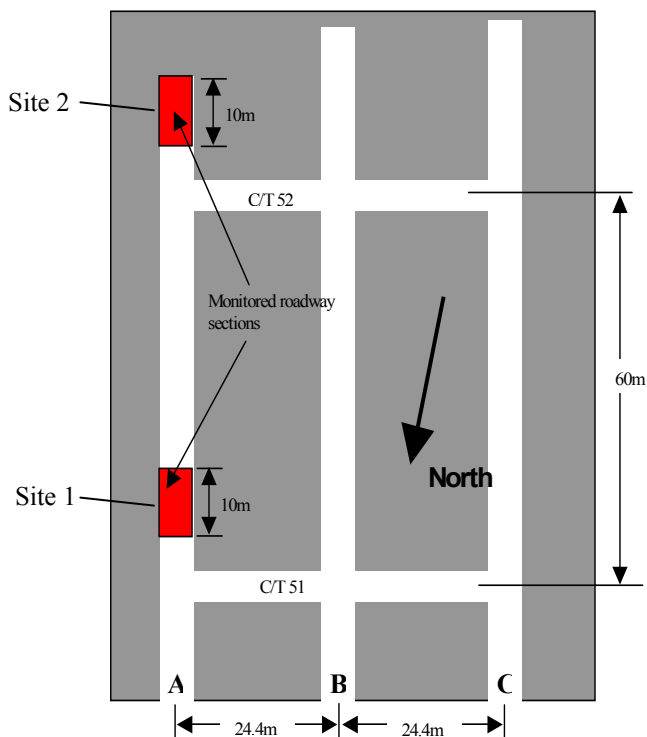
FIG. 2 - Mining layout and the monitored sections of the roadway heading A.

Two sections of Roadway A at LW 104 (Figure 2) were monitored in the vicinity of the 51 and 52 C/Ts where overburden depth is 220m. The monitoring program included three main components:

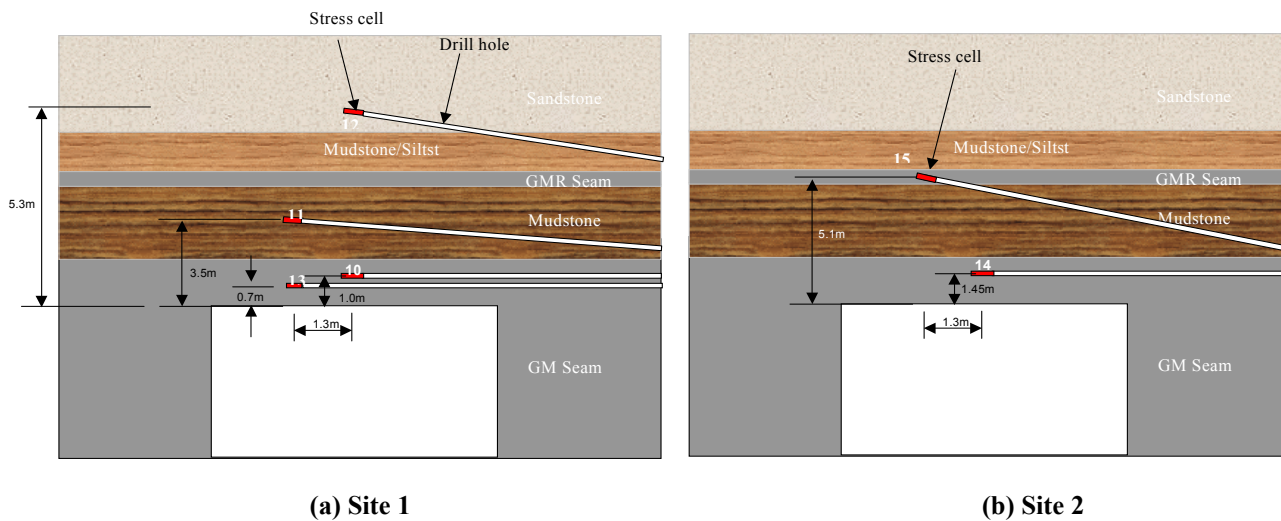
FIG. 3 - Location of stress cells in roof at the two monitoring sites

Four ANZI stress cells were installed at Site 1 and two at Site 2, see Figure 3. The stress cells were located in different roof units and they were installed in boreholes drilled from the cut-throughs prior to the excavation of the monitored roadway sections. Figure 4 shows one such arrangement. After the installation of the stress cells, the roadways were cut in the sequence marked in Figure 4 i.e. 1→2→3→4. The changes of the stresses in the roof were monitored with frequent data reading (every 30 minutes) when the monitored roadway sections were cut.

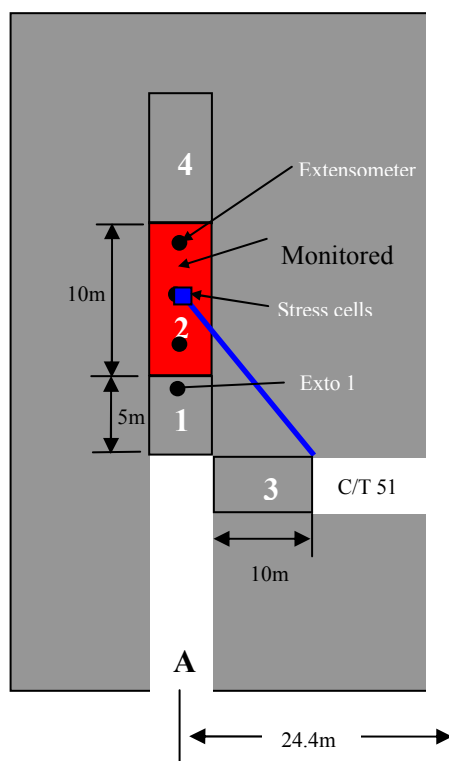
FIG. 4 - Drilling arrangement for stress cell installation and mining steps during monitoring.

Four sonic extensometers were installed in the monitored roadway roof immediately after roof bolting at each site. Displacement data were read as the roadway advanced. The maximum displacement was obtained at the monitored location closest to the cut-throughs (Extensometer 1 at Site 1, see Figure 4, and Extensometer 5 at Site 2). The two extensometers were installed close to the face of previous cut and therefore measured the full roof response to the roadway advance. Other extensometers were installed within the length of the full bolted roadways where much of roof displacement might have already occurred. They hence measured much less roof displacement. The monitored roof displacement from Extensometers 1 and 5 are shown in Figure 7.

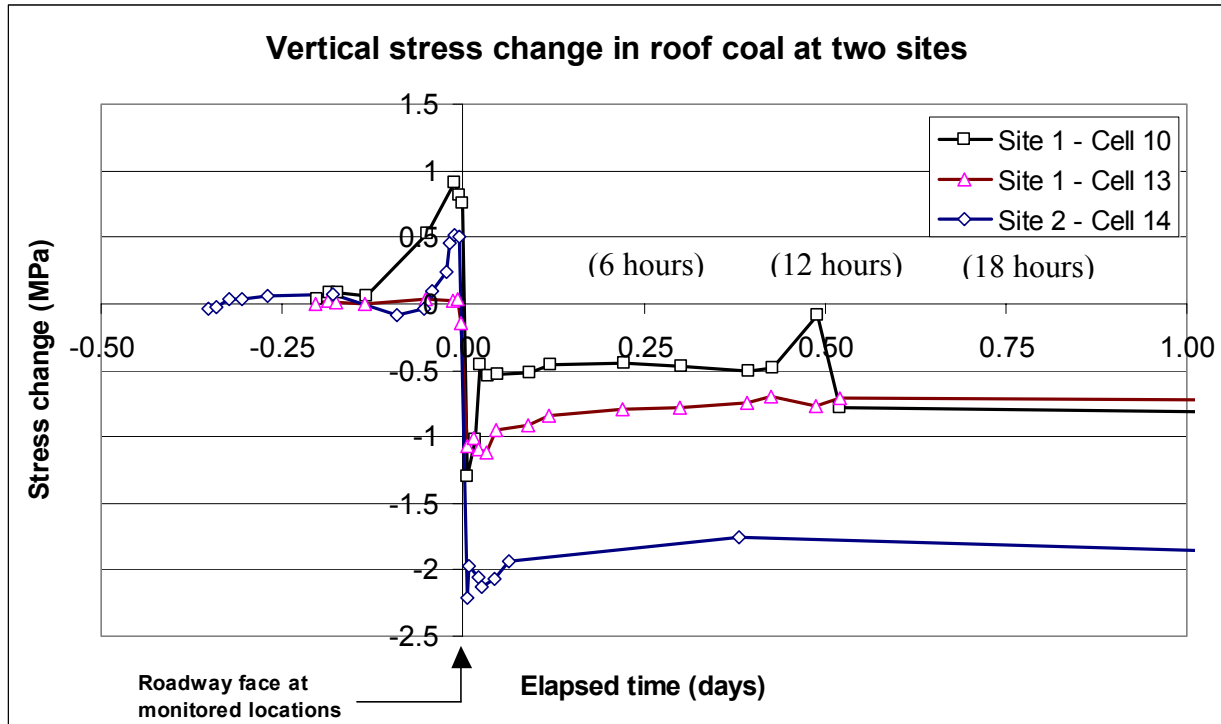
FIG. 6 - Change of vertical stress in the roof coal at the two monitored sites.

The measured stress changes in the roof coal, mudstone and sandstone during roadway advance are shown on a vertical section in Figure 5. The vertical stress change in the roof coal with time is shown in Figure 6

Stresses in the roof rotated when the roadway face approached and passed the monitored locations (FIG. 5). At Site 2, cell 15 in the Rider Seam indicated a change in level and orientation implying shearing along the Rider Seam. Vertical stress in the roof dropped sharply immediately after the roadway face passed the monitored locations (Figure 6).

After the initial stress drop, the vertical stress recovered partially in the next 2-3 hours in the GM Seam (Figure 6) and the mudstone unit. The recovery continued in the next 12 hours at a reduced rate. No vertical stress recovery was observed in the sandstone roof.

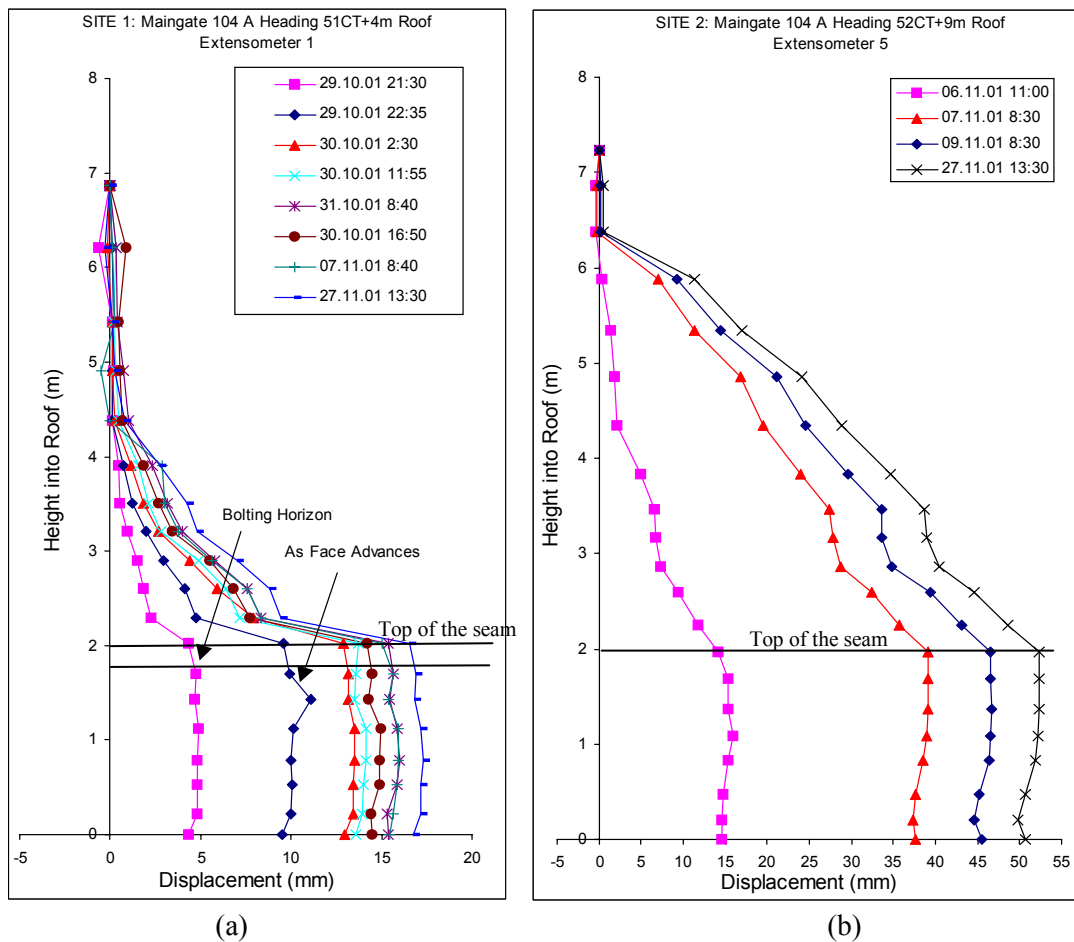
FIG. 7 - Roof displacement at the two monitored sites.

A maximum of 18mm roof movement was recorded at Site 1 (Figure 7a). The recorded displacement is relative to the upper end of the extensometers (7m into roof). The deformation zone extended about 4m into the roof. It is apparent that the bolted roof remained intact as the deformation in the roof coal layer was almost uniform.

The Extensometer 5 at Site 2 recorded a maximum of 50mm roof displacement (Figure 7b), substantially higher than that at Site 1. The deformation zone extended at least 6m into the roof, also higher than that at Site 1.

At the current depth of 220m where the measurements were conducted, the predicted maximum roof displacement is 19 mm. The predicted roof displacement is in a close agreement with the measurements from roof Extensometers 1 (FIG. 7a). The model predictions also show a clear time variation due to the fluid flow after excavation.

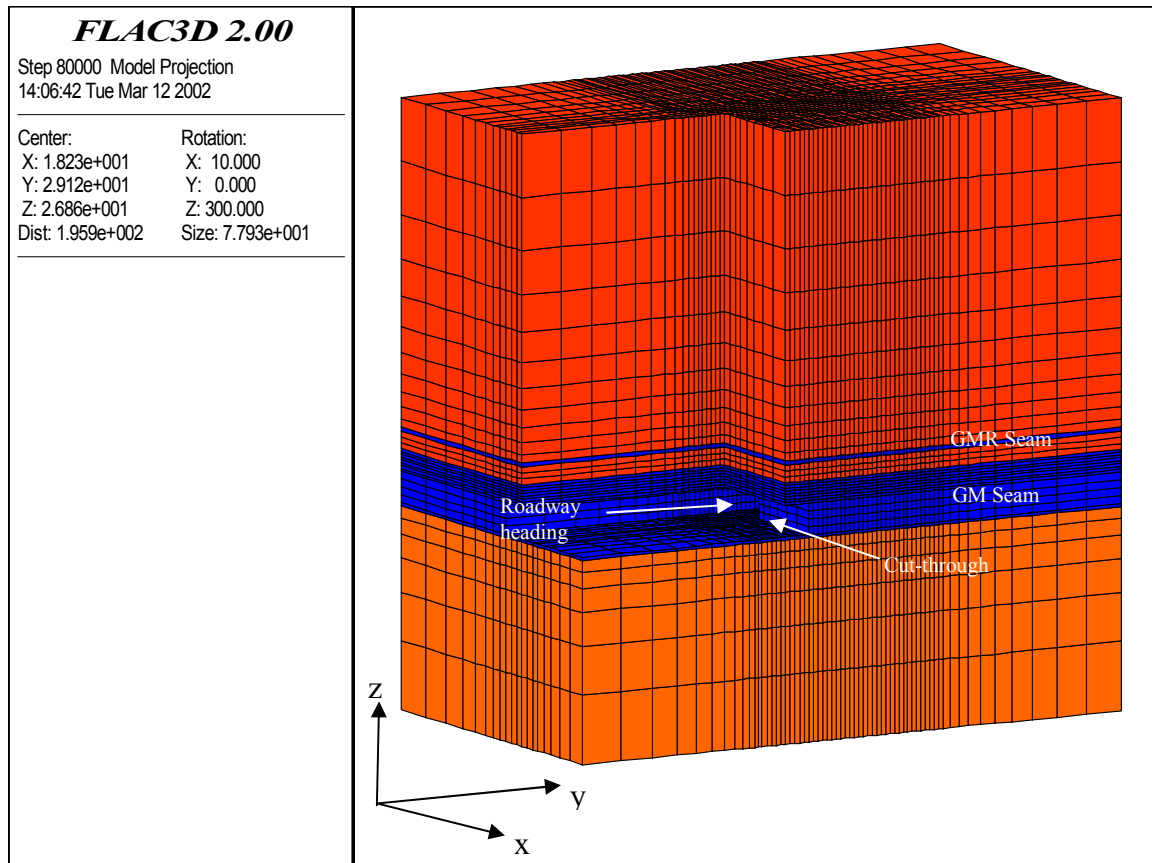
**FIG. 8 - A 3D numerical model for roadway stability at Moranbah North**

The three dimensional numerical simulation of the monitored roadway was conducted using FLAC<sup>3D</sup> (Itasca, 1997). A 3D numerical model was set up based on the simplified geological log shown in FIG. 1. The true mining sequence, including roof and rib bolting, was simulated. The modelled stress change and displacements in the roof were investigated and compared with the measurements. The model geometry is shown in figure 8.

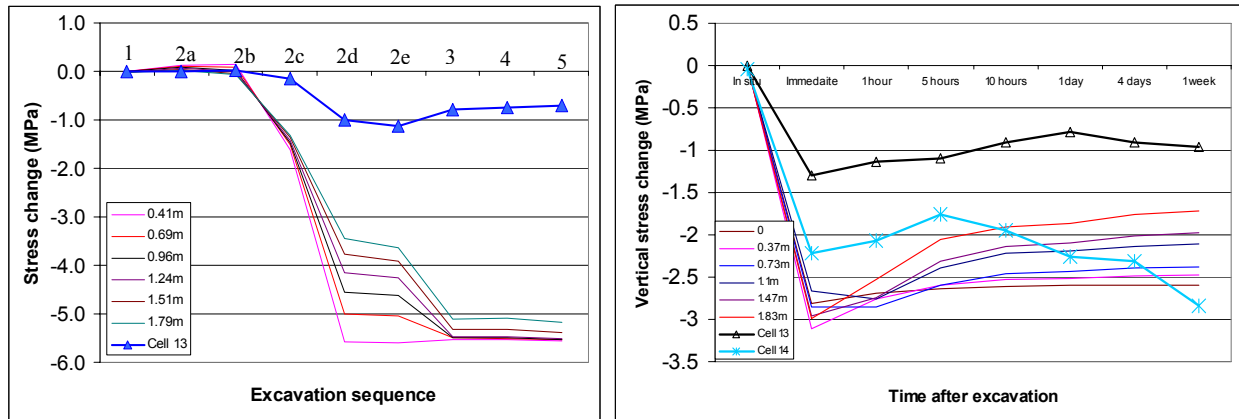
(a) 3D mechanical modelling results

(b) 2D coupled modelling results

**FIG. 9 - Modelled vertical stress change (un-marked lines) in roadway roof at Site 1 in comparison with the measurements (marked lines). The modelled results are given at different distances into the roof. Excavation steps correspond to the roadway sections marked in Figure 4. Steps 2a-2d are excavations of the 10m section 2 with 2.5m increment, 2e is after roof bolting. Step 5 is further advance of the roadway.**

Using the 3D model without considering gas/water pressure, the predicted change of vertical stress in the coal roof during roadway excavation was about 5.5MPa, much higher than measured (see Figure 9a). Unlike the measurements, the model predictions did not show any recovery of the vertical stress in the coal roof after the initial drop.

The 2D model simulated the gas/water pressure and fluid flow in the coal seam during the excavation process. Figure 10 shows the modelled pore pressure distribution 5 hours after roadway excavation. The predicted vertical stress change in the coal roof was in general agreement with the measurements (Figure 9b). The predicted maximum magnitude of the vertical stress change was 2.5-3.0MPa, closer to the measurements of 1.3MPa at Site 1. More importantly, the modelling results showed a clear stress recovery after the initial stress drop, consistent with the measurements.

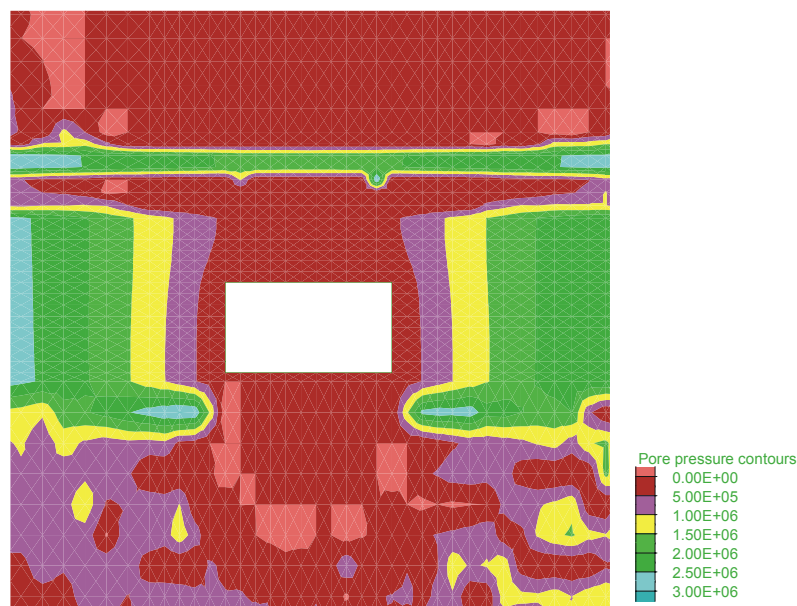
**FIG. 10 - Pore pressure distribution around roadway, 5 hours after excavation**

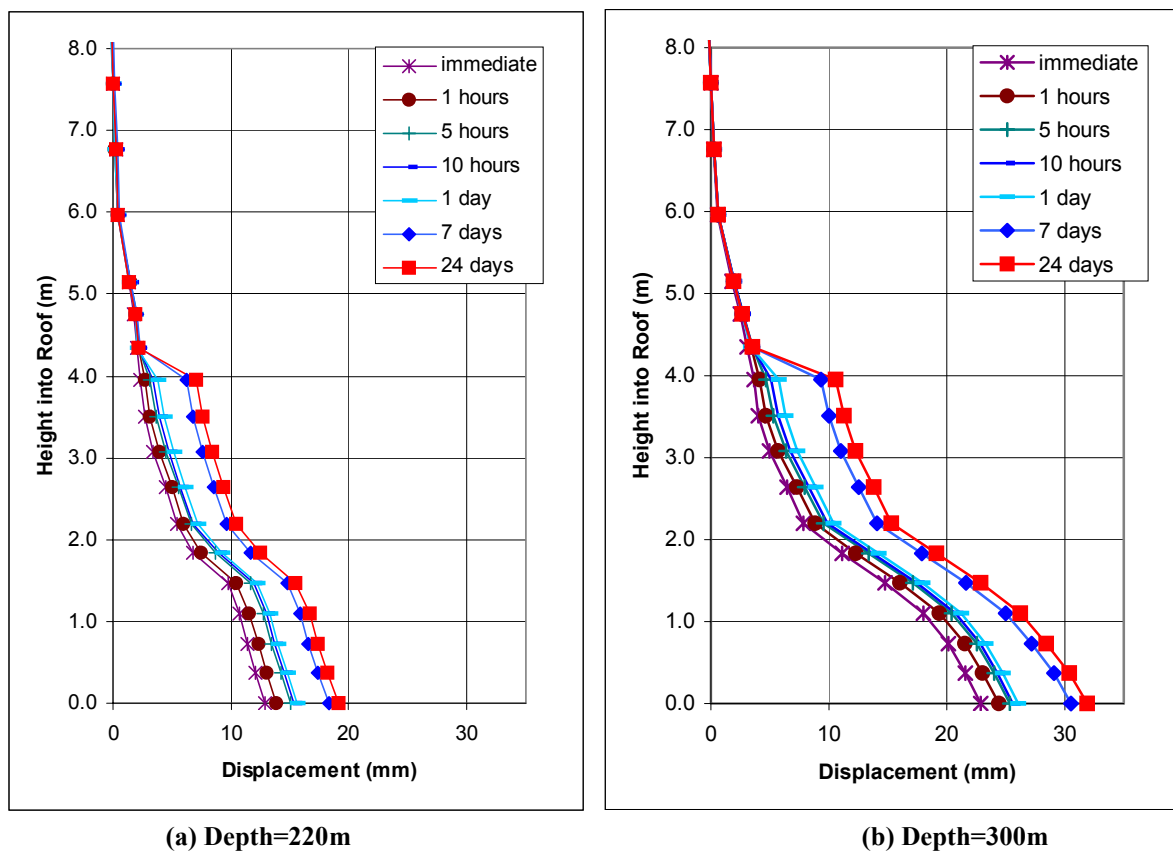
FIG. 11 - Modelled roof displacements at two different depths. The time dependency is caused by fluid flow in the coal seam after roadway excavation.

Additional modelling was conducted using the 2D coupled mechanical-fluid flow model at different depths. The modelled roof displacement at two depths (220m and 300m) are plotted and compared in FIG. 11. The case of increased depth will also be relevant to the Site 2 condition where higher *in situ* stress existed, equivalent to a deeper location.

At the depth of 300m, the predicted maximum roof displacement is 32mm, significantly higher than that at the depth of 220m.
