Coal Operators' Conference

# Roadway Span Stability in Thick Seam Mining -Field Monitoring and Numerical Investigation at Moranbah North Mine

# ROADWAY SPAN STABILITY IN THICK SEAM MINING - FIELD MONITORING AND NUMERICAL INVESTIGATION AT MORANBAH NORTH MINE

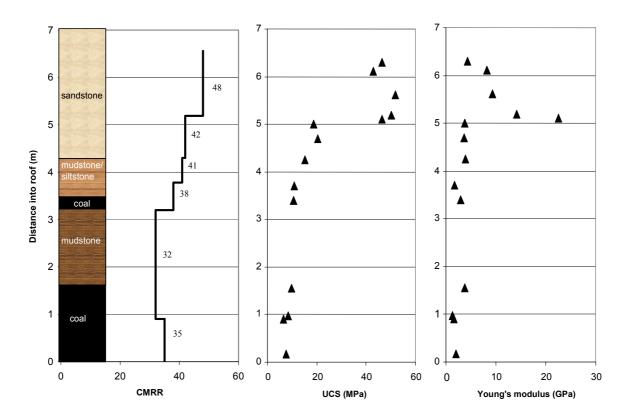
The geology from the drill holes is generally consistent. The typical roof geology in the monitored area is shown in Figure 1. The immediate roof is 1.7m coal. It is of C3 type (40-60% bright) immediately above the roof and becomes dull coal with bright bands at the top of the seam. Overlying the coal seam is a weak to very weak mudstone unit. The mudstone unit has a thickness of about 1.8m. Above this unit is the Goonylla Rider Seam (GMR) which has an average thickness of 0.2m. Above the GMR unit is a sequence of mudstone/siltstone/sandstone units.

Also shown in Figure 1 is the Coal Mine Roof Rating (CMRR) for different roof units. The roof coal and the mudstone units have a CMRR value  $\leq$  35 (Figure 1). According to Mark (1999), unsupported roadway spans with a CMRR less than 46 are considered to be unstable in the long term.

Fourteen coal and rock samples selected from the roof cores were tested in uniaxial compression to determine the strength and deformability (Cunnington and Boland, 2002). The tested Uniaxial Compressive Strength (UCS) and Young's modulus (E) are also plotted in Figure 1.

FIG. 1 - Roof geology, CMRR, rock strength and Young's modulus in the monitored holes

The three dimensional numerical simulation of the monitored roadway was conducted used FLAC<sup>3D</sup> (Itasca, 1997). A 3D numerical model was set up based on the simplified geological log shown in FIG. 1. The true mining sequence, including roof and rib bolting, was simulated. The modelled stress change and displacements in the roof were investigated and compared with the measurements. The model geometry is shown in figure 8.

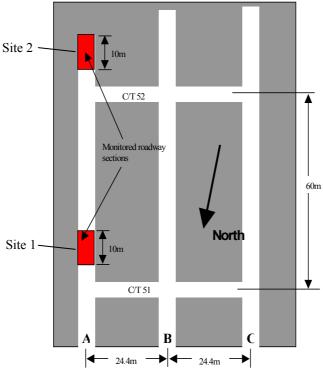
Two sections of Roadway A at LW 104 (Figure 2) were monitored in the vicinity of the 51 and 52 C/Ts where overburden depth is 220m. The monitoring program included three main components:

FIG. 2 - Mining layout and the monitored sections of the roadway heading A.

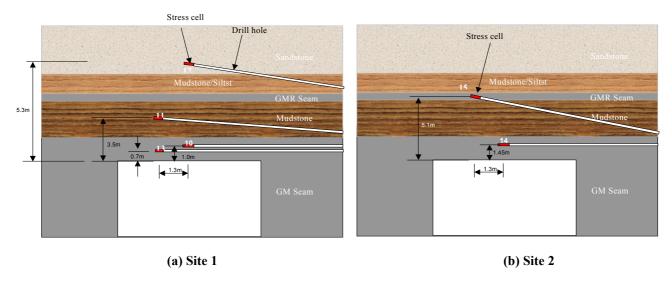
Four ANZI stress cells were installed at Site 1 and two at Site 2, see Figure 3. The stress cells were located in different roof units and they were installed in boreholes drilled from the cut-throughs prior to the excavation of the monitored roadway sections. Figure 4 shows one such arrangement. After the installation of the stress cells, the roadways were cut in the sequence marked in Figure 4 i.e.  $1\rightarrow2\rightarrow3\rightarrow4$ . The changes of the stresses in the roof were monitored withfrequent data reading (every 30 minutes) when the monitored roadway sections were cut.

FIG. 3 - Location of stress cells in roof at the two monitoring sites

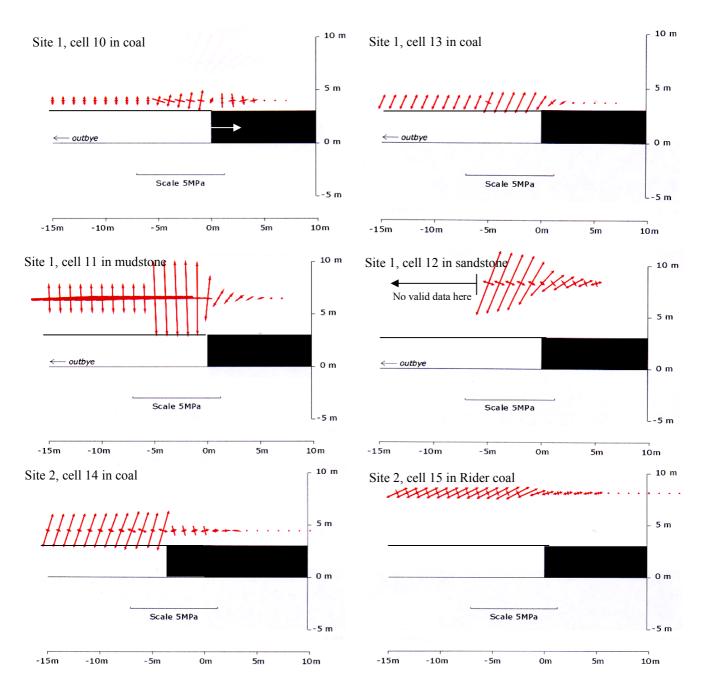
The measured stress changes in the roof coal, mudstone and sandstone during roadway advance are shown on a vertical section in Figure 5. The vertical stress change in the roof coal with time is shown in Figure 6

Stresses in the roof rotated when the roadway face approached and passed the monitored locations (FIG. 5). At Site 2, cell 15 in the Rider Seam indicated a change in level and orientation implying shearing along the Rider Seam. Vertical stress in the roof dropped sharply immediately after the roadway face passed the monitored locations (Figure 6).

FIG. 5 - Monitored stress change in roof coal and rock units versus roadway face position in a vertical cross section parallel to the roadway axis. Outward arrow indicates reduction of compressive stresses

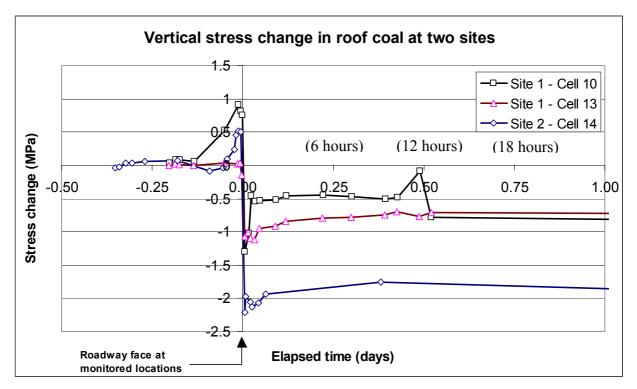
After the initial stress drop, the vertical stress recovered partially in the next 2-3 hours in the GM Seam (Figure 6) and the mudstone unit. The recovery continued in the next 12 hours at a reduced rate. No vertical stress recovery was observed in the sandstone roof.

FIG. 6 - Change of vertical stress in the roof coal at the two monitored sites.

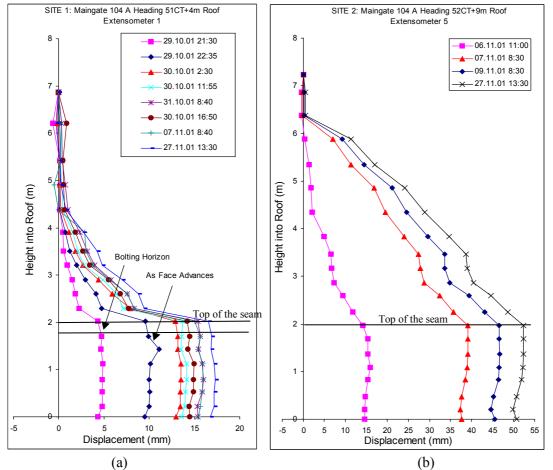
Four sonic extensometers were installed in the monitored roadway roof immediately after roof bolting at each site. Displacement data were read as the roadway advanced. The maximum displacement was obtained at the monitored location closest to the cut-throughs (Extensometer 1 at Site 1, see Figure 4, and Extensometer 5 at Site 2). The two extensometers were installed close to the face of previous cut and therefore measured the full roof response to the roadway advance. Other extensometers were installed within the length of the full bolted roadways where much of roof displacement might have already occurred. They hence measured much less roof displacement. The monitored roof displacement from Extensometers 1 and 5 are shown in Figure 7.

A maximum of 18mm roof movement was recorded at Site 1 (Figure 7a). The recorded displacement is relative to the upper end of the extensometers (7m into roof). The deformation zone extended about 4m into the roof. It is apparent that the bolted roof remained intact as the deformation in the roof coal layer was almost uniform.

The Extensometer 5 at Site 2 recorded a maximum of 50mm roof displacement (Figure 7b), substantially higher than that at Site 1. The deformation zone extended at least 6m into the roof, also higher than that at Site 1.

FIG. 7 - Roof displacement at the two monitored sites.

At the current depth of 220m where the measurements were conducted, the predicted maximum roof displacement is 19 mm. The predicted roof displacement is in a close agreement with the measurements from roof Extensometers 1 (FIG. 7a). The model predictions also show a clear time variation due to the fluid flow after excavation.

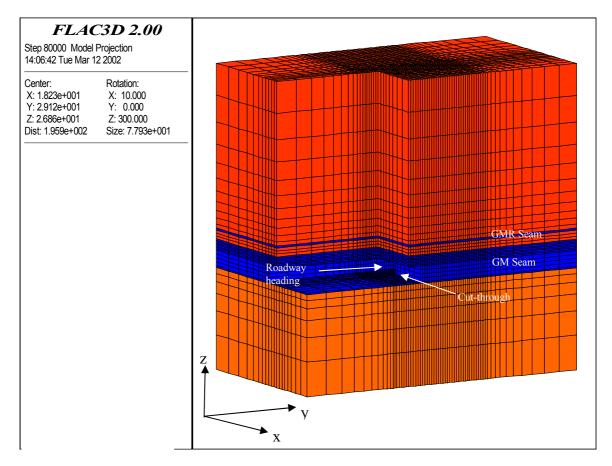
FIG. 8 - A 3D numerical model for roadway stability at Moranbah North

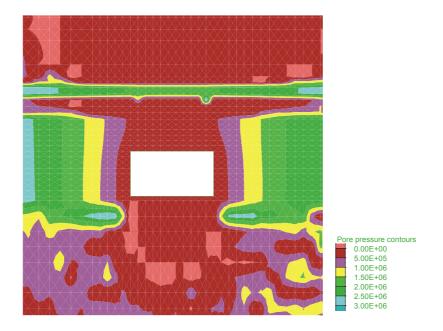
The 2D model simulated the gas/water pressure and fluid flow in the coal seam during the excavation process. Figure 10 shows the modelled pore pressure distribution 5 hours after roadway excavation. The predicted vertical stress change in the coal roof was in general agreement with the measurements (Figure 9b). The predicted maximum magnitude of the vertical stress change was 2.5-3.0MPa, closer to the measurements of 1.3MPa at Site 1. More importantly, the modelling results showed a clear stress recovery after the initial stress drop, consistent with the measurements.

FIG. 10 - Pore pressure distribution around roadway, 5 hours after excavation

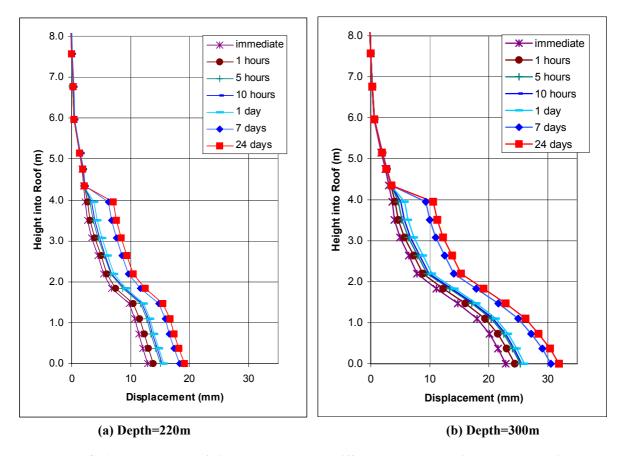
Additional modelling was conducted using the 2D coupled mechanical-fluid flow model at different depths. The modelled roof displacement at two depths (220m and 300m) are plotted and compared in FIG. 11. The case of increased depth will also be relevant to the Site 2 condition where higher *in situ* stress existed, equivalent to a deeper location.

At the depth of 300m, the predicted maximum roof displacement is 32mm, significantly higher than that at the depth of 220m.

FIG. 11 - Modelled roof displacements at two different depths. The time dependency is caused by fluid flow in the coal seam after roadway excavation.
