Gibsons Colliery - Thin Seam and Ultra Close Mining

K. Singer

This conference paper was originally published as Singer, K, Gibsons Colliery - Thin Seam and Ultra Close Mining, in Aziz, N (ed), Coal 2002: Coal Operators' Conference, University of Wollongong & the Australasian Institute of Mining and Metallurgy, 2002, 185-192.

GIBSONS COLLIERY – THIN SEAM AND ULTRA CLOSE MINING

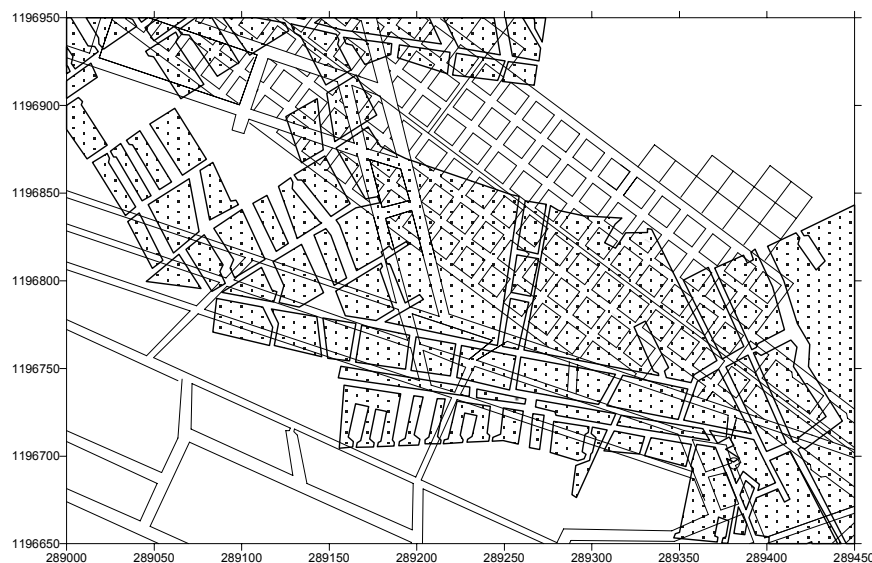
Fig. 1 Plan of Mining Area

Fig. 1 shows a non-validated digitised version of the plan over the immediate area of interest: the Bulli Seam pillars are shown. Taking this interpretation at face value, Gibson's Colliery will be located under large pillars and goaf.

Knowledge of the remnant pillars in the Bulli Seam is based on the original cloth plans held by the colliery. These show areas of hatching marked "pillars extracted" or similar. The nature of the remnant pillars inside such areas is unknown – it is possible that there are large pillars or stooks left in these areas. Elsewhere the plans show Welsh bords and main headings.
