## Roadway Span Stability in Thick Seam Mining - Field Monitoring and Numerical Investigation at Moranbah North Mine

# ROADWAY SPAN STABILITY IN THICK SEAM MINING - FIELD MONITORING AND NUMERICAL INVESTIGATION AT MORANBAH NORTH MINE

*ABSTRACT:* Comprehensive field monitoring and numerical analyses of roadway span behavior have been conducted at Moranbah North Mine as part of an ACARP Project for Rapid Roadway Development. The response of the coal roof to roadway development in a 5.5m thick seam was studied. The monitoring program was highlighted by successfully measuring the roof stress change prior to, during and after the roadway excavation. Roof displacement was also monitored after the installation of roof support.

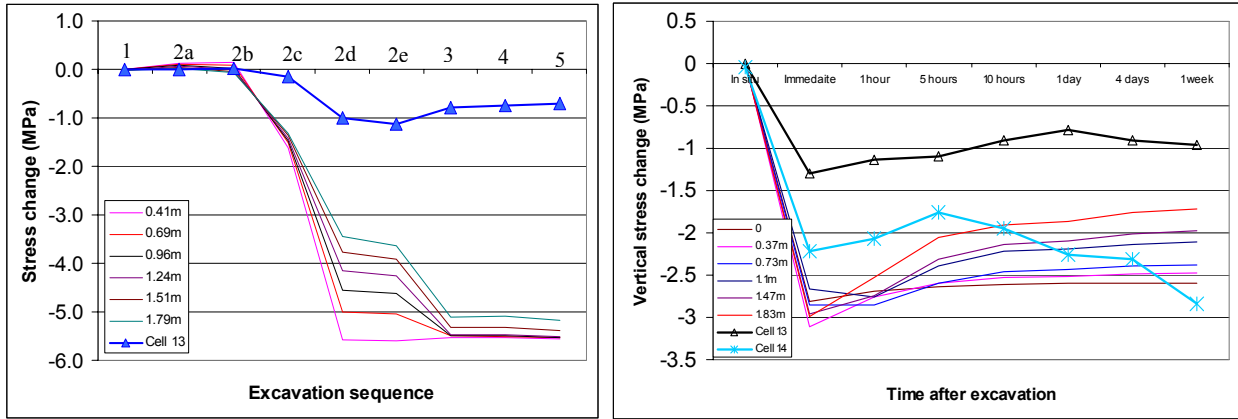
(a) 3D mechanical modelling results

(b) 2D coupled modelling results

**FIG. 9 - Modelled vertical stress change (un-marked lines) in roadway roof at Site 1 in comparison with the measurements (marked lines). The modelled results are given at different distances into the roof. Excavation steps correspond to the roadway sections marked in Figure 4. Steps 2a-2d are excavations of the 10m section 2 with 2.5m increment, 2e is after roof bolting. Step 5 is further advance of the roadway.**

The predicted stress changes in the coal roof from the 2D and 3D modelling are plotted in Figure 8..

Using the 3D model without considering gas/water pressure, the predicted change of vertical stress in the coal roof during roadway excavation was about 5.5MPa, much higher than measured (see Figure 9a). Unlike the measurements, the model predictions did not show any recovery of the vertical stress in the coal roof after the initial drop.

The 2D model simulated the gas/water pressure and fluid flow in the coal seam during the excavation process. Figure 10 shows the modelled pore pressure distribution 5 hours after roadway excavation. The predicted vertical stress change in the coal roof was in general agreement with the measurements (Figure 9b). The predicted maximum magnitude of the vertical stress change was 2.5-3.0MPa, closer to the measurements of 1.3MPa at Site 1. More importantly, the modelling results showed a clear stress recovery after the initial stress drop, consistent with the measurements.
