## **A New Corosion Resistant Ground Support System**

# A NEW CORROSION RESISTANT GROUND SUPPORT SYSTEM

**ABSTRACT:** The capacity of ground support components which have been affected by corrosion is reduced and may ultimately lead to failure of the component and the strata. In order to maintain an effective, long-term ground support system, significant campaigns of rehabilitation are often required in corrosion affected areas. The most common corrosion protection for steel ground support utilises sacrificial systems such as galvanising. Galvanising has previously been proven to be susceptible to some corrosion processes. Stainless steel is the most effective in resistance to corrosion, but can be cost prohibitive, and its mechanical properties often make it unsuited for use in ground support components.

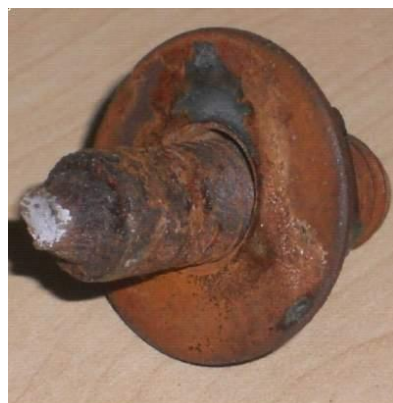
Figure 1: Corroded and failed roof bolt

Traditionally, the most common form of corrosion protection in steel ground support consists of a sacrificial protective coating such as galvanising. Such coatings have proven to be ineffective in extreme high and low pH conditions with corrosion of the support system commonly encountered. There is also evidence that common forms of galvanising may actually increase the rate of corrosion in certain pH environments. Figure 1 shows typical corrosion and failure on a standard re-bar roof bolt.

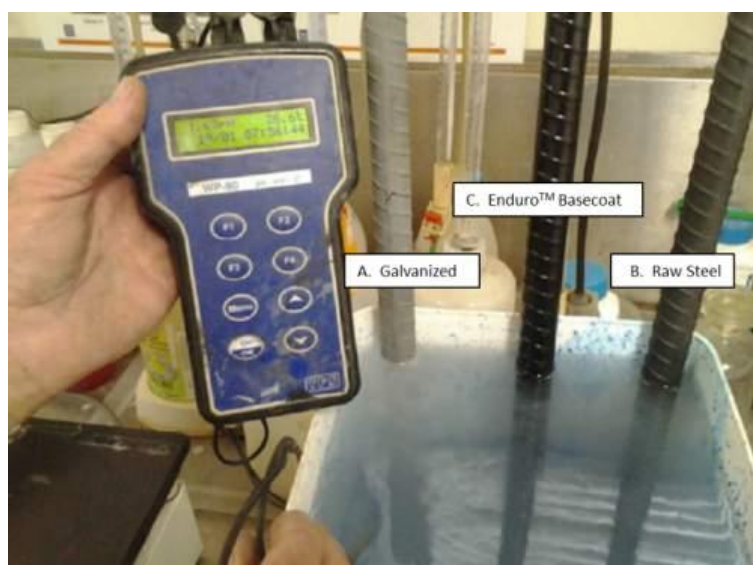
Figure 4: Acid bath and pH monitoring instrument used during Enduro™ product testing

The acid bath and pH measuring instrument is shown in Figure 4.

Immediately upon immersion, the hot-dip galvanized bolt (grey colour – Figure 4a) commenced ‘fizzing’ (reacting). The raw steel bolt (charcoal colour- Figure 4b) commenced reacting after approximately 30 minutes. Over a period of testing there was no apparent reaction with the black Enduro™ base coated bolt (Figure 4c).

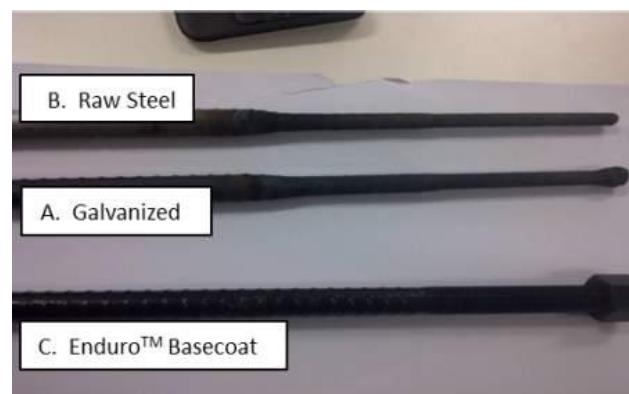
**Figure 6: Acid bath immersion testing results after 50 days**

After 50 days (Figure 6) both the raw steel and galvanised bolts have corroded significantly with the nut on the galvanised bolt completely corroded. There were still no obvious signs of corrosion on the Enduro™ bolt.

From the observations it is clear that the galvanised and the raw steel bolt were severely corroded after 50 days of immersion. The Enduro™ bolt still looked 'intact' with no apparent corrosion evident. The dissolution pattern of the raw and galvanised bolts appears different;

- the raw bolt appears to be dissolving uniformly with the nut showing severe corrosion.
- the galvanised bolt shows severe pitting and complete dissolution of the nut.

In both cases, the threaded areas of the raw steel and galvanised bolt area has been significantly reduced in diameter. The Enduro™ nut and thread is observed to be unaffected showing no signs of corrosion (Figure 6).

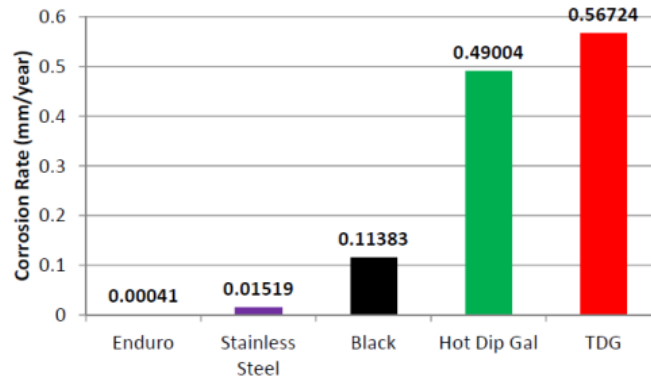
**Figure 7: Average calculated corrosion rate of Enduro™ and comparison samples in 3.5% NaCl solution, pH 2**

testing. The accelerated corrosion testing procedure used included taking potentiodynamic polarization measurements using a typical three-electrode electrochemical cell that was connected with a Bio-Logic potentiostat. Prior to each corrosion test the Open Circuit Potential (OCP) was measured to confirm stability over a period of 1000 seconds. A total of five bolt materials were tested that included; Enduro™ with base coat, black (e.g. ungalvanised), hot dip galvanisation, Thermally Diffused Galvanisation (TDG) and stainless steel. Results for each of the products at pH 2 are presented in Figure 7.

The Enduro™ product specimens provided the best observed corrosion resistance in acidic conditions (3.5% NaCl at pH 2) followed by stainless steel and then the other products tested. It can be observed that HDG and TDG coatings have extremely low resistance to corrosion from low pH solutions

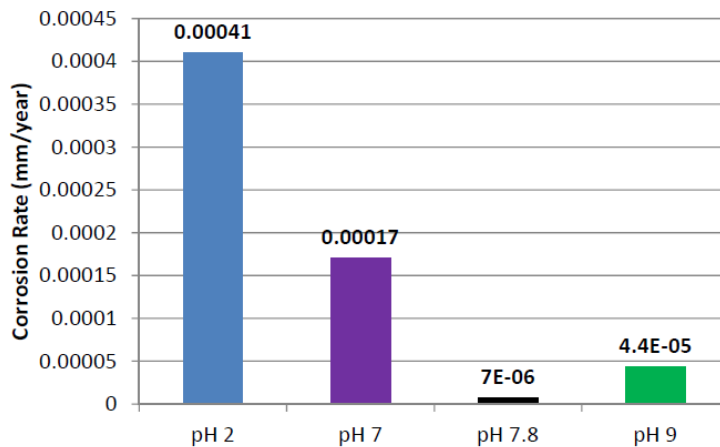
**Figure 8: Enduro Corrosion (mm/yr) calculated at various pH levels**

The corrosion performance of the Enduro™ product (basecoat only) over a range of pH conditions is provided in Figure 8 for the purposes of estimating service life.

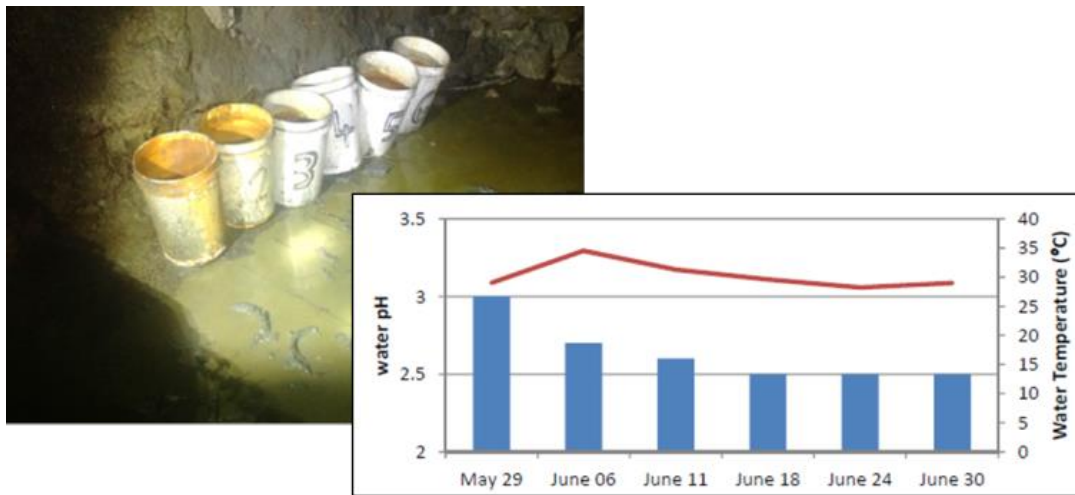
Figure 9: Mine A Bolt in situ test conditions

Six sections of Enduro™ bolts (Type A) and six sections of Hot Dip Galvanised bolts (Type B) were selected for use in this trial. Each section was 600 mm in length. The bolts were placed underground in free running/draining acidic water as shown in Figure 9. The pH was measured once a week and is also provided in Figure 9.

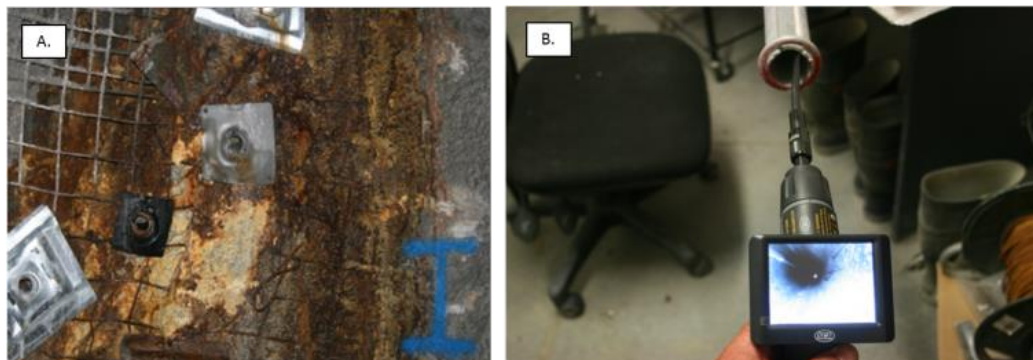
**Figure 12: Observed corrosion of existing galvanized ground support through surface and penetrating visual means at Mine B**

At Mine B, *in situ* trial sites for the Enduro™ product were selected based on a significant observed degradation in the existing galvanised split-set support which had been installed approximately three years previously and was re-supported. Figure 12a shows a heavily corroded split set and plate that has been installed for approximately two weeks. Visual observations regarding the corrosion of the bolts have been made in addition to corrosion assessments of the inside of the bolts using a hand-held wand camera (Figure 12b). The performance of the Enduro™ product was measured (along with what is called red bolt) over a two month period whereby exposure of the bolts was maximised by placing them on the floor under dripping mine water (Figure 13). In order to replicate mining conditions the bolts were extensively scratched and scoured on the inside and outside. The extent of corrosion on the bolts was recorded every month. The red-bolt and the black Enduro™ bolt showed minimal evidence of corrosion over a two month period.

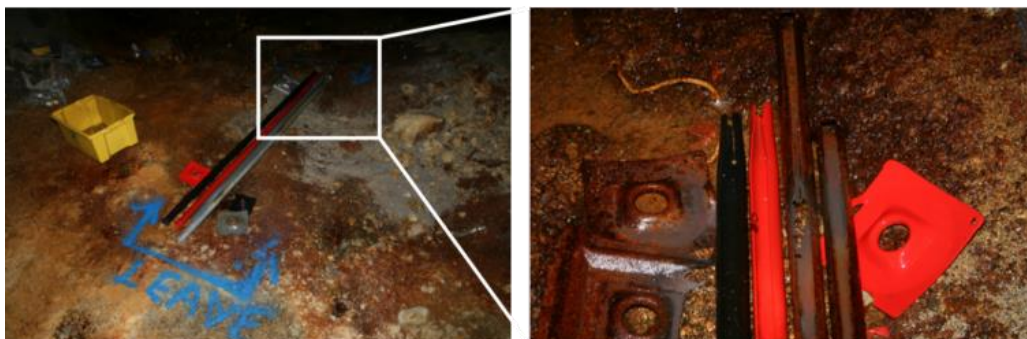
**Figure 13: Observed corrosion of Enduro™ (black) and (red-bolt) at Mine B**
