### Microstructural characterization of P91 steel in the virgin, service exposed and post-service re-normalized conditions

## Microstructural characterization of P91 steel in the virgin, service exposed and post-service re-normalized conditions

Li, H. & Mitchell, D. (2013). Microstructural characterization of P91 steel in the virgin, service exposed and post-service re-normalized conditions. *Steel Research International*, 84 (12), 1302-1308.

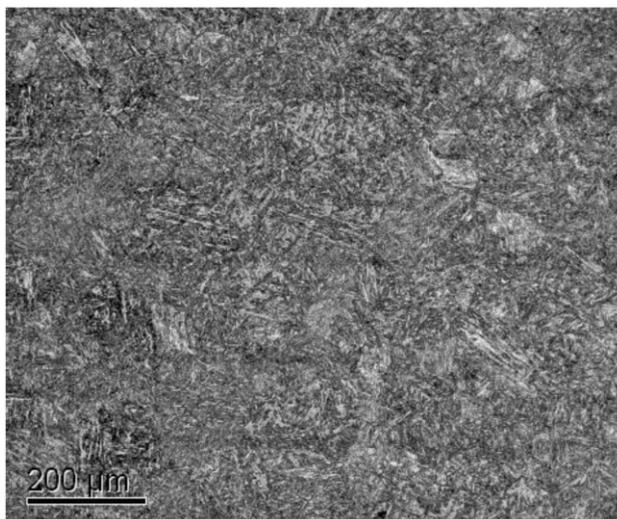
**Figure 1.** Virgin Steel – optical micrographs showing the tempered martensitic structure.

The virgin steel exhibited a microstructure typical of tempered martensite (Figure 1). The prior austenite grain

boundaries were not very apparent, nor were carbides. There was some indication of micron-sized particles, but the superior resolution of TEM was required to characterize these.

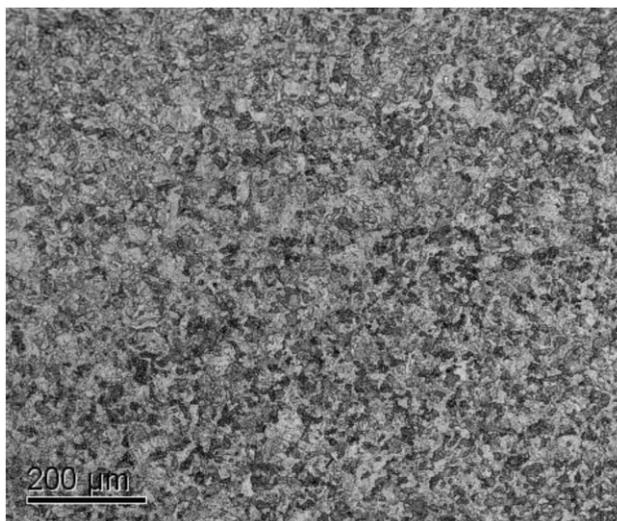
**Figure 2.** Service-exposed steel, the microstructure has changed to an equiaxed one in sharp contrast to the tempered martensitic structure of the virgin steel.

The microstructure of the service-exposed steel (Figure 2) was modified as a result of time at temperature, when compared with the virgin steel (Figure 1). The equiaxed grain structure in the service exposed material was in marked contrast to the tempered martensitic structure of the virgin steel. The mean grain size in the service exposed material was about  $25 \mu\text{m}$ . Detailed observation showed the presence of carbides. These were

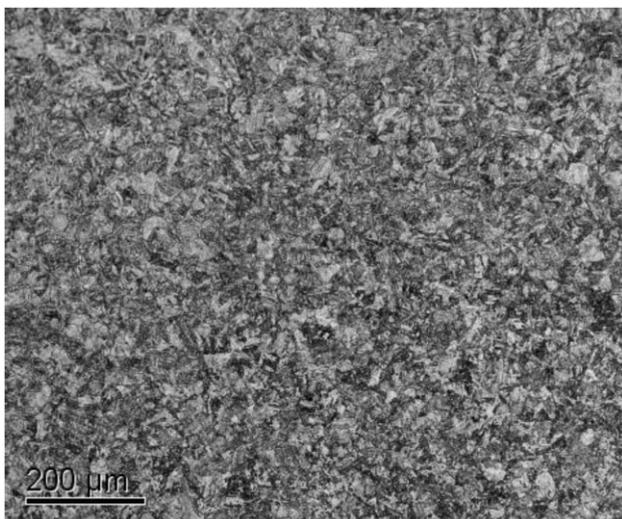
**Figure 3.** Re-normalized steel, the microstructure is martensitic, but the grains are very evident, far more so than in the virgin steel.

Low powered optical microscopy showed the grain structure of re-normalized steel, with grain sizes in the range 20–40  $\mu\text{m}$  (Figure 3). This grain structure was more apparent in the re-normalized service exposed material compared with virgin steel. The martensitic lath structure was evident. However, comparison with that of the virgin steel showed that the lath uniformity of the renormalized steel was more irregular than that of the virgin steel, and the prior austenite grain boundaries were much more apparent. Carbides were visible in both microstructures, being of similar dimensions.

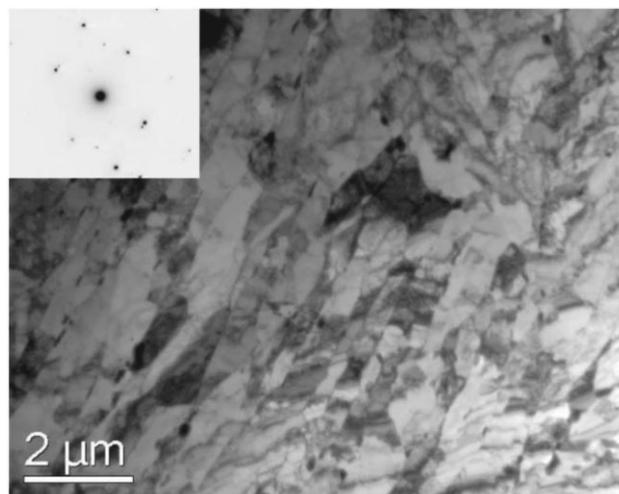
**Figure 4.** Virgin steel. Thin foil tilted close to [001] (insert) showing the marked lath structure running parallel to [100].

A region of the thin foil was tilted close to [001] (Figure 4, insert) and pronounced lath structure became apparent (Figure 4). The long axes of the laths was parallel to [100]. The lath structure was fairly uniform, with a mean lath width of about 0.4  $\mu\text{m}$ . Under appropriate two beam conditions dislocation structures were evident within the laths as sub-grains, while the density of discrete dislocations within the laths was not high. More detailed examination of the laths (Figure 5) showed the presence of some coarse carbides. These were generally on the lath boundaries, and were elongated parallel to the long axes of the laths. Carbides were 50–150 nm wide and up to 300 nm long. Qualitative EDS analysis of the carbides showed that they were Cr-rich. A very small number of what appeared to be fine carbides, as well as individual dislocations, were present within laths. These fine scale carbides could not be analyzed in these thin foil specimens. Quantitative analysis of the coarse carbides was possible by careful probing of

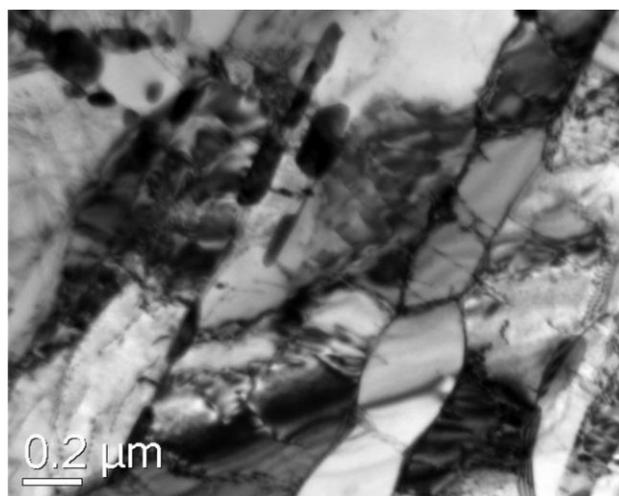
**Figure 5.** Virgin steel. Thin foil showing a detail of the lath structure showing Cr-rich elongated carbides mainly on the lath boundaries.

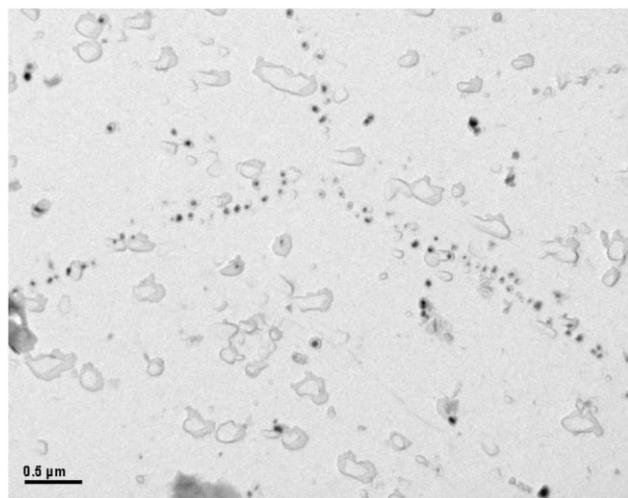
**Figure 6.** Virgin steel extraction replicas showing a) alignment of fine scale Nb/V-rich carbides parallel to, and slightly displaced from similar alignments of failed extractions of larger Cr rich carbides.

Replication of the virgin steel (**Figure 6**) extracted a large proportion of the very fine carbides also seen in the thin foil specimens. These were typically sub-50 nm diameter and mainly globular. These fine carbides were arranged in lines suggesting that they tended to precipitate on the lath and subgrain boundaries. The location of the fine carbides near the lath boundaries would tend to obscure them somewhat in the thin foils because of dislocation structures, contrast changes between laths and subgrains and the presence of larger Cr-rich carbides. Also apparent in the replicas were a number of large depressions in the carbon film. These were 200–400 nm in diameter, being failed extractions of the coarse Cr-rich carbides, which were very apparent in the thin foil images (e.g., **Figure 5**). These failed extractions were also arranged in rows parallel to the rows of fine scale carbides, though slightly displaced. It is not clear why this displacement exists. This may be a

consequence of lath/subgrain boundary movement during tempering, combined with precipitation of the two carbide types at different stages of the tempering process.

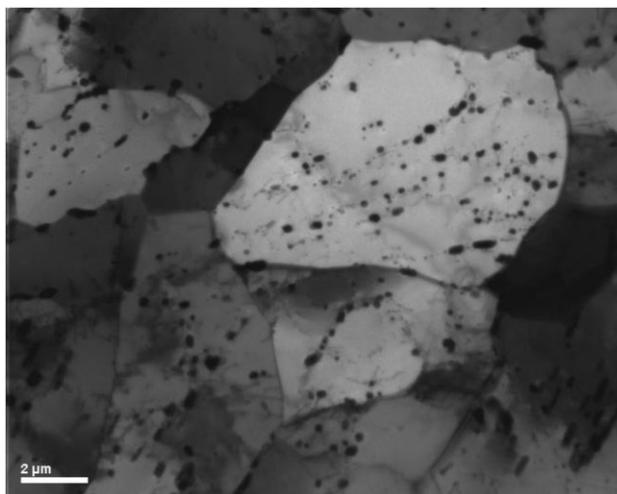
**Figure 7.** Service-exposed steel. Thin foil specimen showing the grains, the loss of lath and dislocation structures, and the coarse Cr-rich carbides delineating the former lath boundaries.

Thin foil examination on service-exposed steel (**Figure 7**) highlighted the dramatic difference between this steel and the virgin material. Much of the lath and subgrain structure had been lost, with the prior austenite grain structure being evident. Average grain diameters measured optically were  $\approx 25 \mu\text{m}$ . Within the grains the coarse carbides delineated the original lath boundaries, being arranged in parallel stripes with a spacing of about  $0.4 \mu\text{m}$ . Clearly extensive recovery had taken place due to service exposure and the lath, sub-grain and dislocations present in the virgin steel has been lost. This recovery was also reflected in the extensive softening which occurred due to service (Table 2). Higher magnification imaging (**Figure 8**) highlighted the remnant lath microstructure delineated by the coarse 200–400 nm carbides. This carbide configuration was also observed in optical microscopy. Occasional fine carbides (sub-50 nm) were present both within grains and within rows of coarse carbides. The dislocation density was very much lower than in the virgin steel.

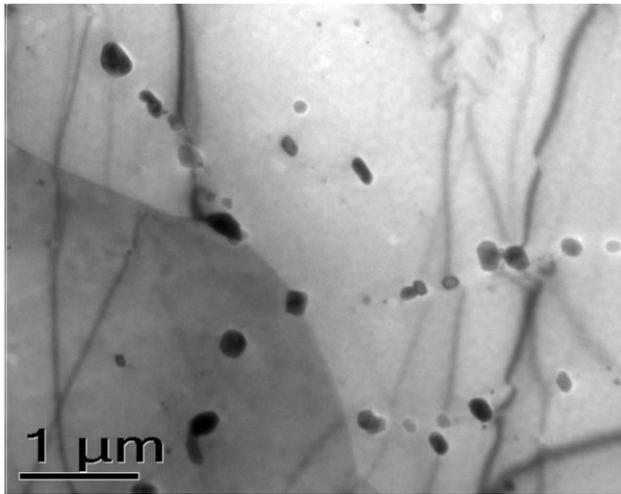
**Figure 8.** Service-exposed steel. Thin foil specimen. Showing a grain boundary, and coarse Cr-rich carbides within grains delineating former lath boundaries. Carbides have become less elongated and more faceted as a result of service exposure.

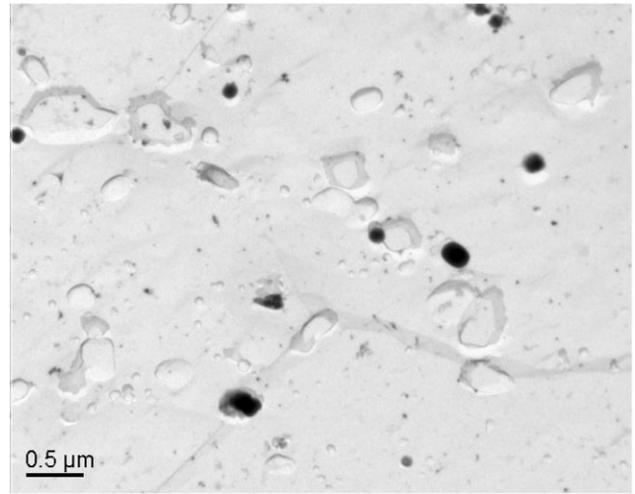
**Figure 9.** Service-exposed steel. Extraction replica showing the spherical fine scale Nb-rich carbides and the impressions of larger Cr-rich carbides which failed to extract.

Extraction replication of this steel (**Figure 9**) again extracted the fine scale carbides, with impressions left in

the carbon film of failed extractions of the larger coarse carbides. All the extracted carbides were roughly spherical, suggesting that the service exposure has caused spheroidization of these carbides. Almost all the carbides in Figure 9 are NbC. It would therefore appear that significant coarsening and some secondary precipitation of very fine NbC carbides has occurred due to service exposure. This also seemed to have occurred for the coarse carbides. In the virgin steel many of the carbides were elongated while after service exposure carbides tended to be more globular and in some cases strongly faceted (Figure 8). EDS analysis of the fine scale carbides showed that they were Nb-rich containing ca 80 wt% of the element, with much of the

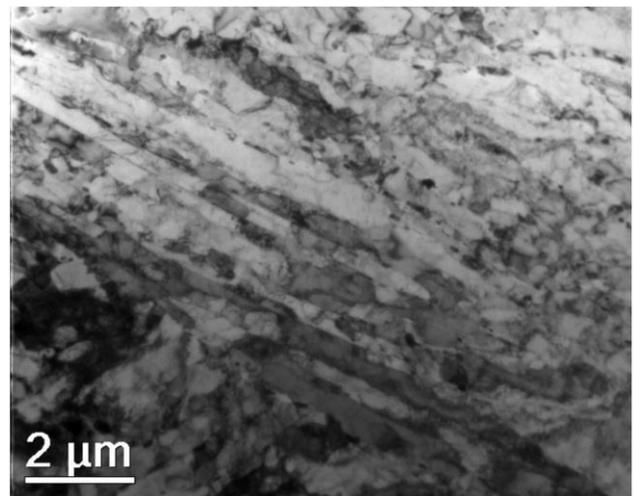
**Figure 10.** Renormalized steel thin foil specimen showing how the heat treatment has restored the lath and dislocation microstructure seen in the virgin steel. The mean lath width is 0.4 mm.

Low magnification imaging of a re-normalized steel thin foil (Figure 10) under imaging conditions identical to those used for the previous specimens showed that renormalizing had restored the lath microstructure seen in the virgin steel. The average lath width was also similar at about 0.4 μm. More detailed examination showed the presence of subgrain structures within the laths as well as elongated Cr-rich carbides on the lath boundaries. It was difficult to see fine scale precipitates against the background of dislocation contrast. This microstructure was very similar

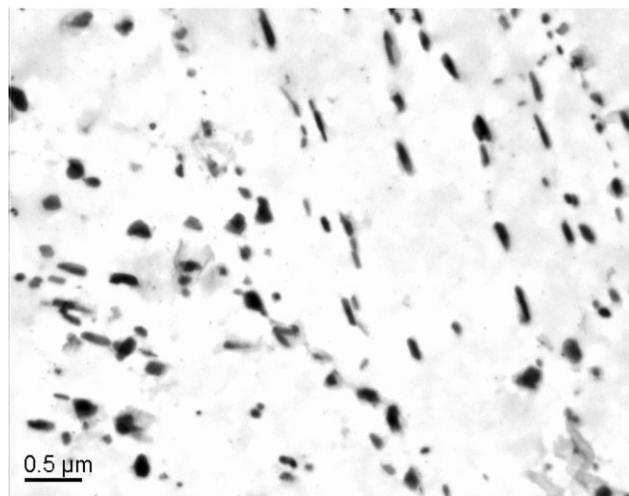
**Figure 11.** Renormalized steel extraction replica specimen showing how both coarse and fine carbides have been extracted. EDS analysis of the coarse carbides confirms the analysis of similar carbides projecting over the edge of thin foil specimens.

Examination of replicas from renormalized steel sample showed that a larger proportion of the carbides has been extracted so that coarse Cr-rich as well as fine Nb-rich carbides were present on the replica (Figure 11). EDS

analysis of the coarse scale Cr-rich carbides produced a mean composition very similar to that reported above. As well as the coarse elongated carbides ( $\approx 200$  nm long), which outlined the lath microstructure, there were some fine Cr-containing carbides present. These were very fine  $\approx 20$  nm. However, none of these were NbC.
