## Developing Methods for Placing Sand-Propped Hydraulic Fractures for Gas Drainage in the Bulli Seam

## DEVELOPING METHODS FOR PLACING SAND-PROPPED HYDRAULIC FRACTURES FOR GAS DRAINAGE IN THE BULLI SEAM

**ABSTRACT:** BHP Billiton Illawarra Coal is seeking ways to significantly increase gas capture rates from in seam drilling programs in its underground coal mining operations. Hydraulic Fracture Technology (HFT), a joint venture between SCT Operations Pty Ltd and CSIRO Petroleum, is working with Illawarra Coal to develop the capability to enhance gas drainage rates in the Bulli Seam using sand-propped hydraulic fracturing based on HFT's experience at Dartbrook Mine where gas drainage rates were increased by 5 to 180 times.

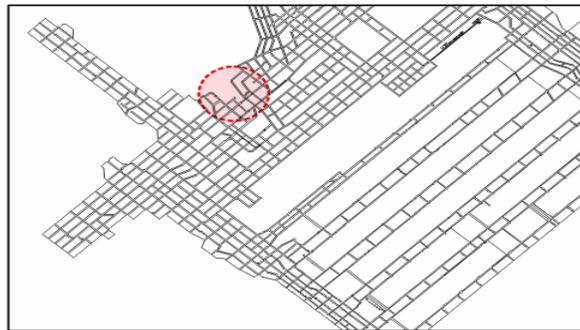
Figure 1 shows a plan of the Douglas Project pit-bottom trial site. The roadways in this area were developed some 25 years ago. A major geological fault structure is located immediately to the north-east of the site. The seam RL at the site is approximately 310 m below AHD. The surface is approximately 190 m AHD, so the overburden depth is nominally 500 m indicating a vertical stress of approximately 12.5 MPa. The seam thickness is nominally 2.2 m.

**Fig 1a: General location of Douglas site.**

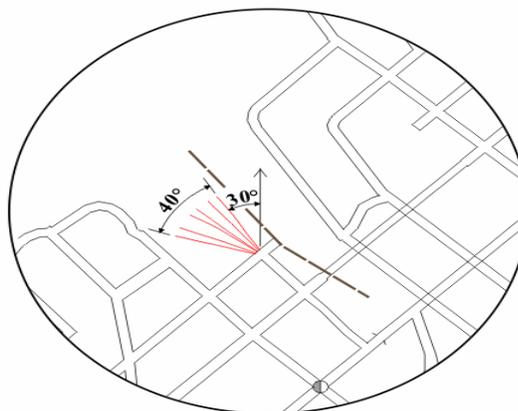
**Fig 1b: Layout of boreholes at Douglas pit bottom.**

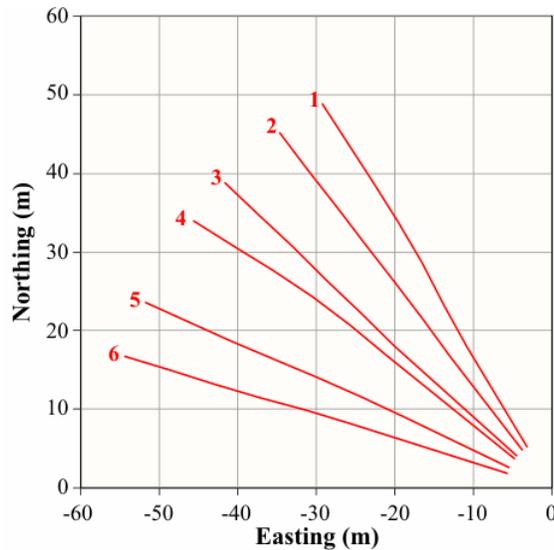
Six holes were drilled using a downhole motor at a nominal diameter of 96 mm. The intention was to drill these holes so that some were dipping down, some up and others with both up-dip and down-dip sections. The alignment of the holes was surveyed using the downhole survey tool. Figure 2 shows a summary of the hole alignments in plan and long section.

**Fig 2a: Plan of borehole alignments based on downhole surveying.**

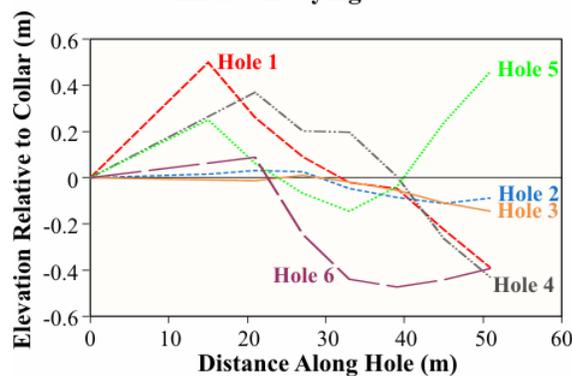
**Fig 2b: Borehole alignments shown in section relative to borehole collar.**

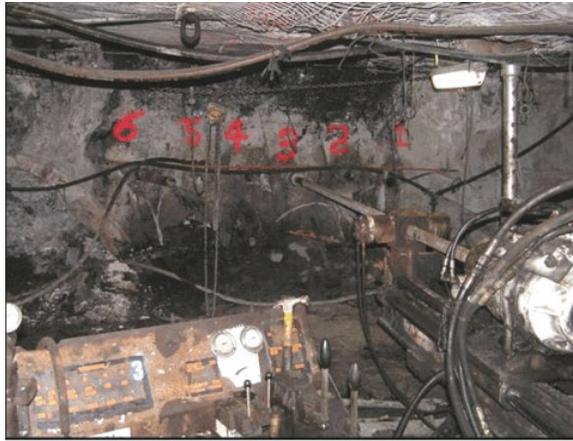
Steel standpipes were installed in all the holes by the drilling crew. The standpipes were 9 m long in Holes 1 and 2 and 12 m long in Holes 3-6. The stand pipe used was nominally 4-inch diameter and had an internal diameter of 105 mm. A 4-inch BSP coupler was attached with a short BSP to Victaulic adapter fitted to the other end of the coupler. The cement head used during the trials was attached to the Victaulic fitting using a quick-set Victaulic clamp. Figure 3 shows a photograph of the site with the holes shown painted in red on the rib and numbered from 1 to 6.

**Fig 3: Photograph of Douglas pit bottom site showing the location of the six 50m long boreholes used for the casing trial.**

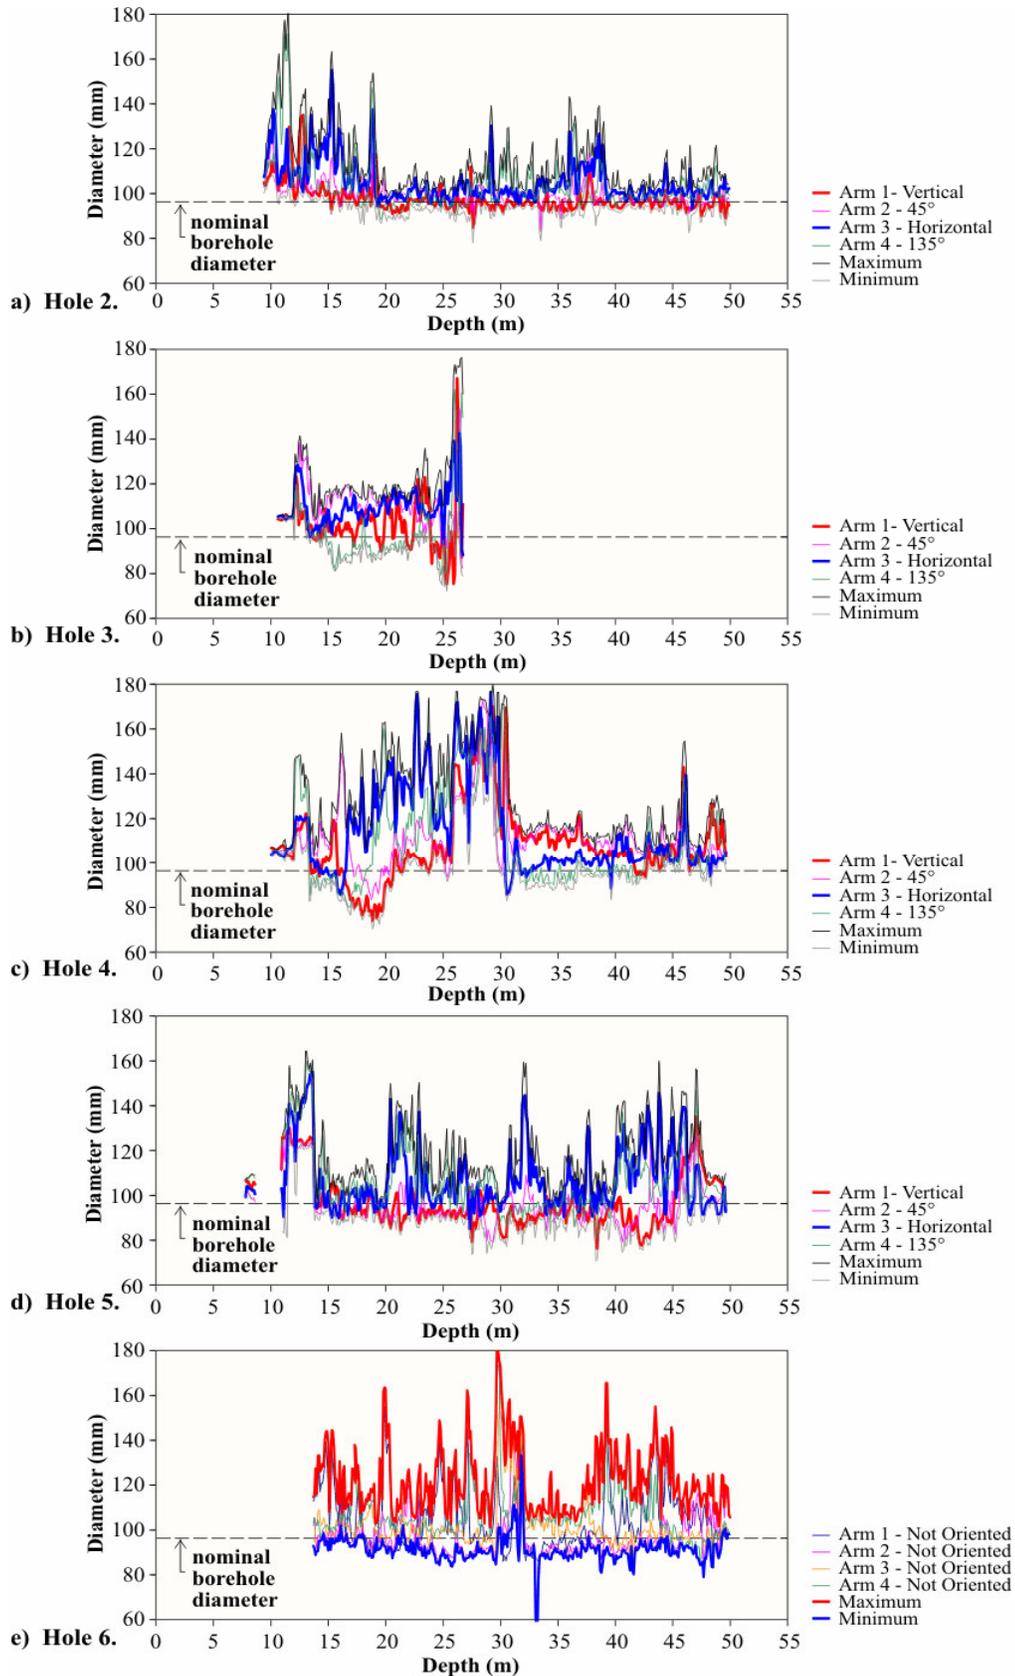
Figure 4 shows the results of caliper logging in each of the holes. The caliper was logged continuously as it was retracted along the hole, but the depth was only measured every 0.1 m. In most of the holes the instrument was able to be oriented within 15° using a downhole tilt indicator, so that the arms were oriented vertical, horizontal, 45°-225° and 135°-315°. The maximum and minimum values measured on any of the arms over each 0.1 m interval are shown as well as the average value measured on each arm.

The caliper logs show that the boreholes have a horizontal diameter greater than the as-drilled diameter over a substantial length of the hole. The horizontal diameter is generally greater than the vertical diameter and ranges up to about 180 mm in some sections. The vertical diameter is typically less than the nominal diameter of the hole. This may be a result of closure due to borehole breakout, but it may also be a function of debris in the bottom of the hole.

Fig 4: Caliper measurements from Holes 2-6 at Douglas.

The key result of the caliper logs is that the boreholes are unsuitable for using open hole straddle packers for hydraulic fracturing without some sort of casing system. If straddle packers were used in these boreholes without casing, the packers would not be expected to provide an effective seal at the treatment pressures of 10-15 MPa and the packers would rupture on a regular basis.

Caliper logging showed that horizontal gas drainage holes drilled in coal at 500m overburden depth are subject to vertical stress sufficient to cause large amounts of borehole breakout and compromise the effective use of straddle packers in open holes. The horizontal diameter was often larger than the 96 mm nominal hole size and in some sections of the holes reached 180mm indicating considerable breakout from vertical overstraining of the borehole.

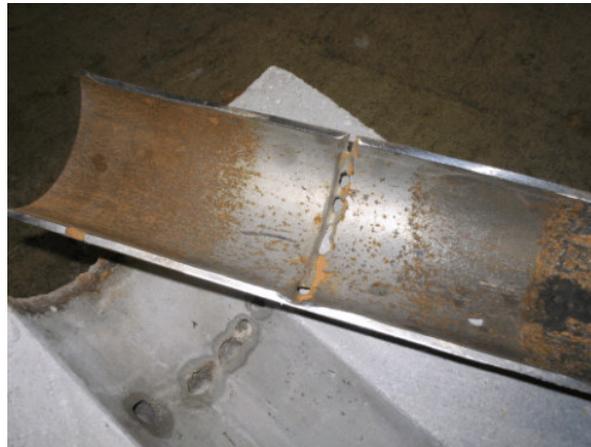
A slotting tool was developed, tested and modified at CSIRO Petroleum in Melbourne. The tool jets were sized so that the steel casing could be cut in about 4 minutes. PVC and fibreglass casing required less time to cut than steel. Figure 5 shows a section of steel casing cut under these conditions. For this test, a short section of casing was encased in a concrete block and then cut using a sand-water slurry pumped at 120 lpm and 13.79 MPa (2000 psi) for 4 minutes. The openings shown in Figure 5 would provide more than enough access to the coal seam for carrying out hydraulic fracture stimulations. Higher cutting pressures are expected to reduce the slotting time further.

**Fig 5: Slot cut into steel casing in yard test, using abrasive slurry.**

Slotting of the casing using the abrasive jet proved to be relative easy. With the pressures available, it took several bags of sand and some 4-10 minutes of pumping to cut a circular slot in the steel casing. Higher pressures and better control of the rotation rate is expected to reduce this timeframe to just a few minutes in normal operation.

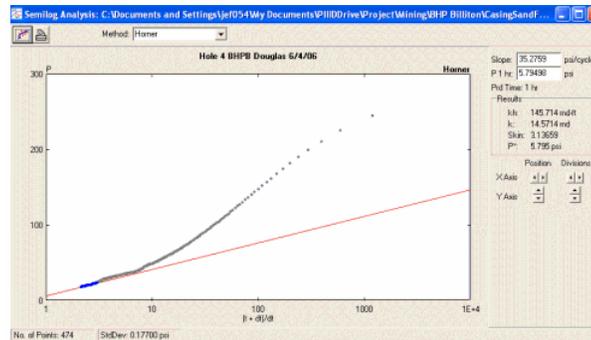
Figure 6 shows the analysis of the falloff data from the well test in Hole 4 at the 25 m slot. This analysis is considered to give the best estimate of reservoir pressure. Figure 7 shows a second analysis plot of the falloff data for the well test in Hole 4 at the 25 m slot which gives the best estimate of permeability.

**Fig 6: Analysis plot of the falloff data from the well test in Hole 4 at the 25m slot. This analysis gives the best estimate of reservoir pressure.**

The flattening of the falloff curve in the Horner plot is indicative of a test carried out by injecting water into an unsaturated seam. The early part of the curve (larger Horner time) where the slope is greater is used to obtain an estimate of the seam permeability. In later times (small Horner time) the pressure is affected by the low gas pressure in the reservoir and the slope tends to flatten and approach the reservoir pressure asymptotically. The intercept of this portion of the curve with a Horner time of 1 provides an estimate of the reservoir pressure. If more accurate estimates of permeability and reservoir pressure are required, the injection and falloff portions of the test should be extended to several hours each.

Notwithstanding the short duration of the tests, permeability of about 5md and a reservoir pressure of about 34 kPa (5 psi) seem reasonable estimates based on the site location. It should also be noted that this analysis assumes radial flow conditions exist while such a short test is expected to take place almost wholly in a spherical flow period.

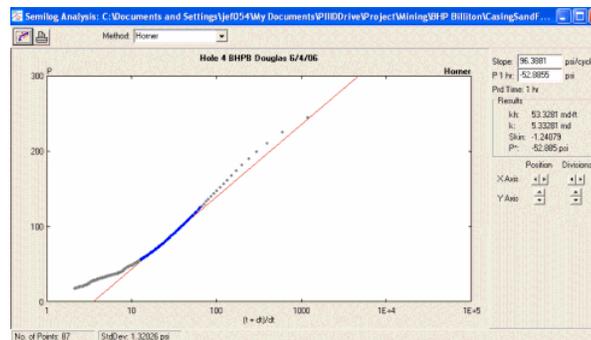
**Fig 7: Second analysis plot of the falloff data for the well test in Hole 4 at the 25m slot. This analysis gives the best estimate of permeability.**
