Developing Methods for Placing Sand-Propped Hydraulic Fractures for Gas Drainage in the Bulli Seam

DEVELOPING METHODS FOR PLACING SAND-PROPPED HYDRAULIC FRACTURES FOR GAS DRAINAGE IN THE BULLI SEAM

ABSTRACT: BHP Billiton Illawarra Coal is seeking ways to significantly increase gas capture rates from in seam drilling programs in its underground coal mining operations. Hydraulic Fracture Technology (HFT), a joint venture between SCT Operations Pty Ltd and CSIRO Petroleum, is working with Illawarra Coal to develop the capability to enhance gas drainage rates in the Bulli Seam using sand-propped hydraulic fracturing based on HFT's experience at Dartbrook Mine where gas drainage rates were increased by 5 to 180 times.

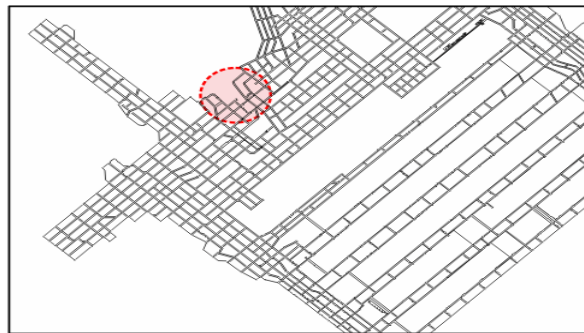
Fig 1a: General location of Douglas site.

Figure 1 shows a plan of the Douglas Project pit-bottom trial site. The roadways in this area were developed some 25 years ago. A major geological fault structure is located immediately to the north-east of the site. The seam RL at the site is approximately 310 m below AHD. The surface is approximately 190 m AHD, so the overburden depth is nominally 500 m indicating a vertical stress of approximately 12.5 MPa. The seam thickness is nominally 2.2 m.

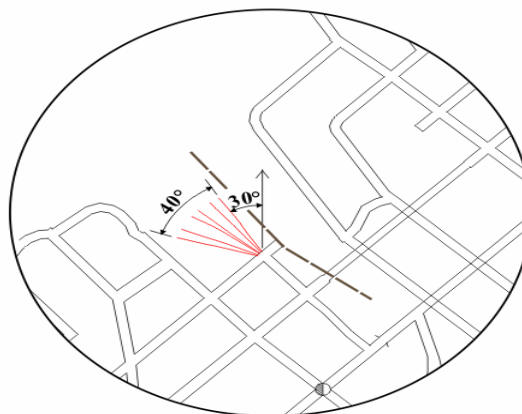
Fig 1b: Layout of boreholes at Douglas pit bottom.

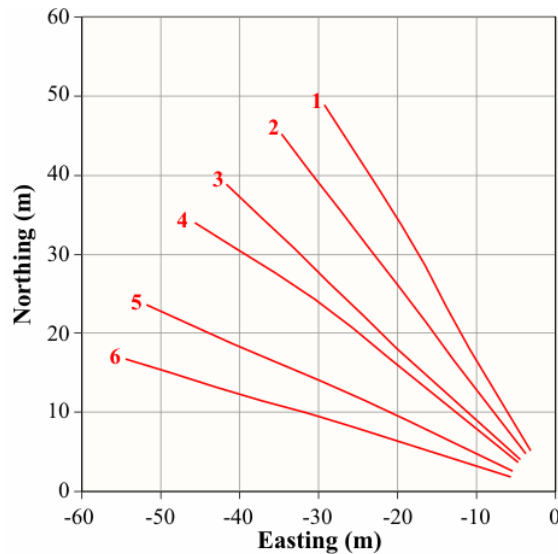
Fig 2a: Plan of borehole alignments based on downhole surveying.

Six holes were drilled using a downhole motor at a nominal diameter of 96 mm. The intention was to drill these holes so that some were dipping down, some up and others with both up-dip and down-dip sections. The alignment of the holes was surveyed using the downhole survey tool. Figure 2 shows a summary of the hole alignments in plan and long section.

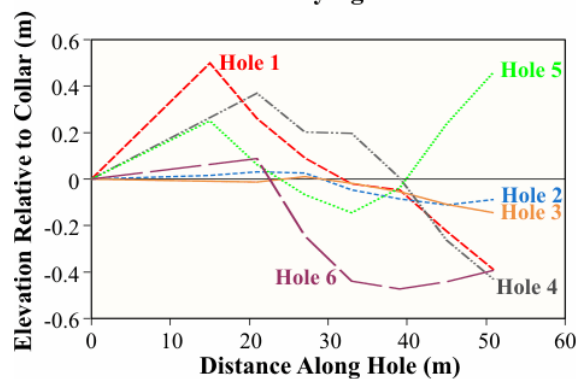
Fig 2b: Borehole alignments shown in section relative to borehole collar.

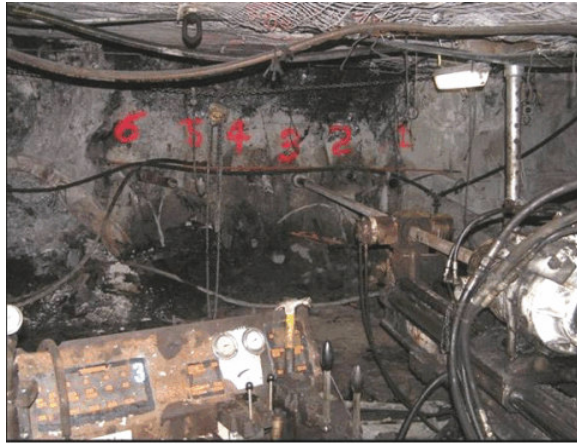
Fig 3: Photograph of Douglas pit bottom site showing the location of the six 50m long boreholes used for the casing trial.

Steel standpipes were installed in all the holes by the drilling crew. The standpipes were 9 m long in Holes 1 and 2 and 12 m long in Holes 3-6. The stand pipe used was nominally 4-inch diameter and had an internal diameter of 105 mm. A 4-inch BSP coupler was attached with a short BSP to Victaulic adapter fitted to the other end of the coupler. The cement head used during the trials was attached to the Victaulic fitting using a quick-set Victaulic clamp. Figure 3 shows a photograph of the site with the holes shown painted in red on the rib and numbered from 1 to 6.

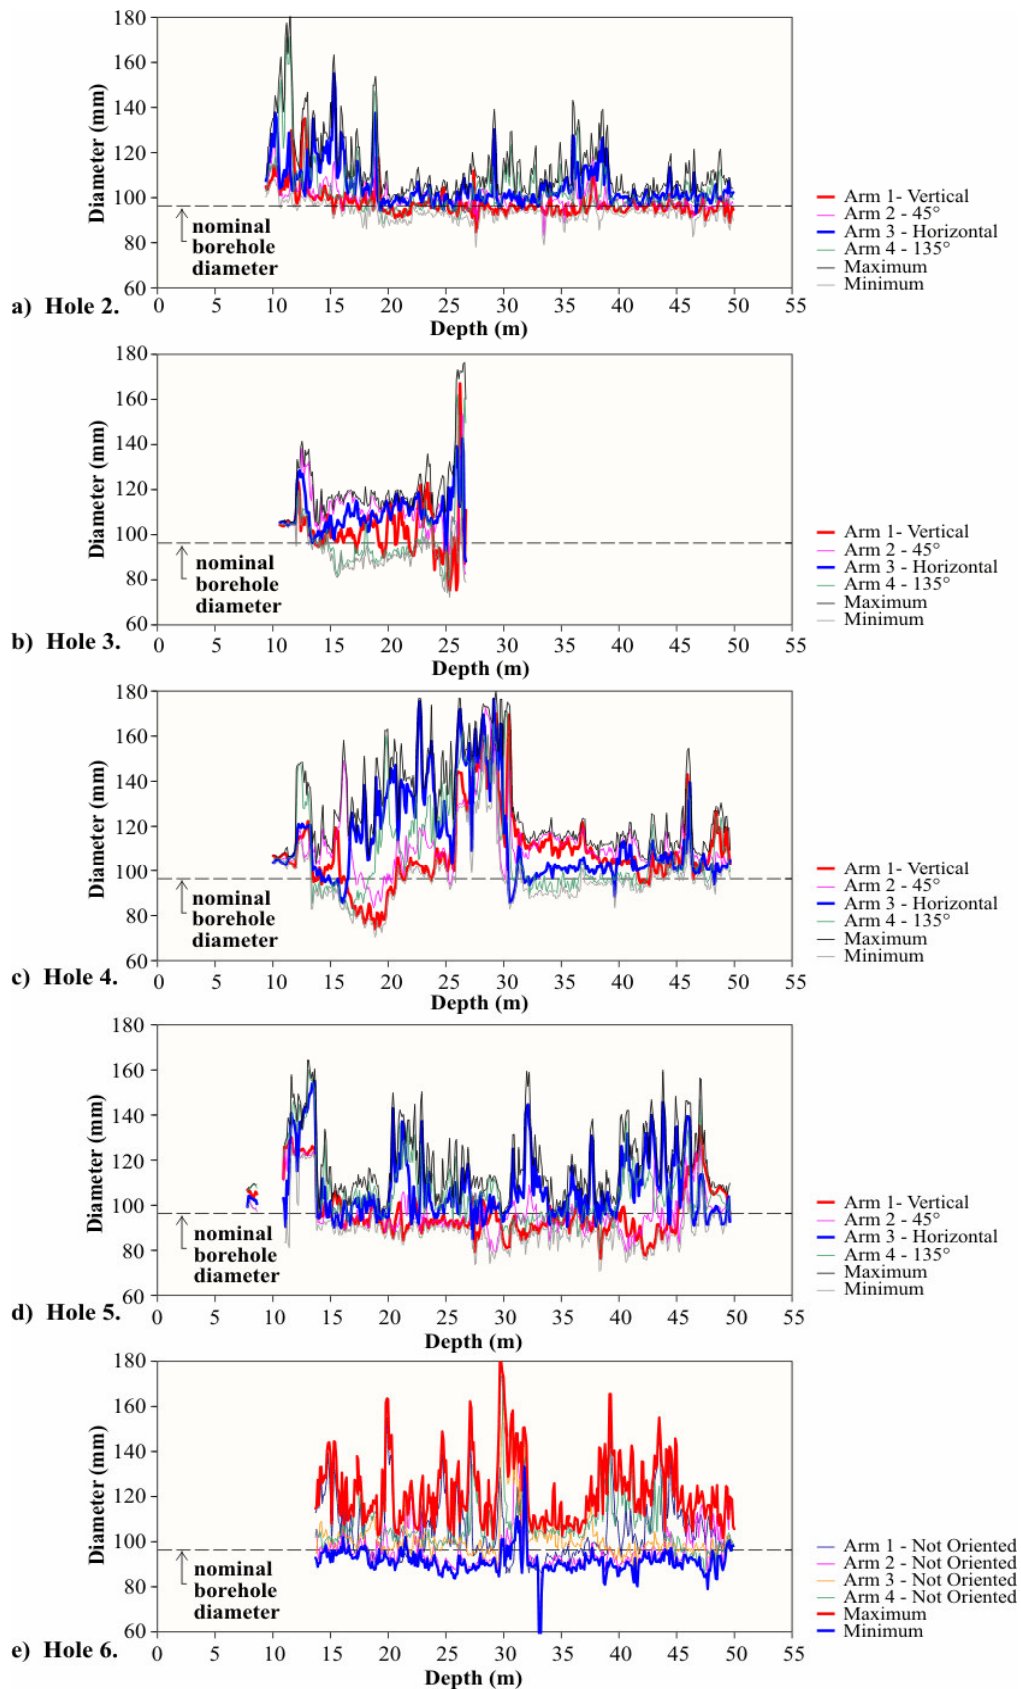
Fig 4: Caliper measurements from Holes 2-6 at Douglas.

Figure 4 shows the results of caliper logging in each of the holes. The caliper was logged continuously as it was retracted along the hole, but the depth was only measured every 0.1 m. In most of the holes the instrument was able to be oriented within 15° using a downhole tilt indicator, so that the arms were oriented vertical, horizontal, 45°-225° and 135°-315°. The maximum and minimum values measured on any of the arms over each 0.1 m interval are shown as well as the average value measured on each arm.

The caliper logs show that the boreholes have a horizontal diameter greater than the as-drilled diameter over a substantial length of the hole. The horizontal diameter is generally greater than the vertical diameter and ranges up to about 180 mm in some sections. The vertical diameter is typically less than the nominal diameter of the hole. This may be a result of closure due to borehole breakout, but it may also be a function of debris in the bottom of the hole.

The key result of the caliper logs is that the boreholes are unsuitable for using open hole straddle packers for hydraulic fracturing without some sort of casing system. If straddle packers were used in these boreholes without casing, the packers would not be expected to provide an effective seal at the treatment pressures of 10-15 MPa and the packers would rupture on a regular basis.

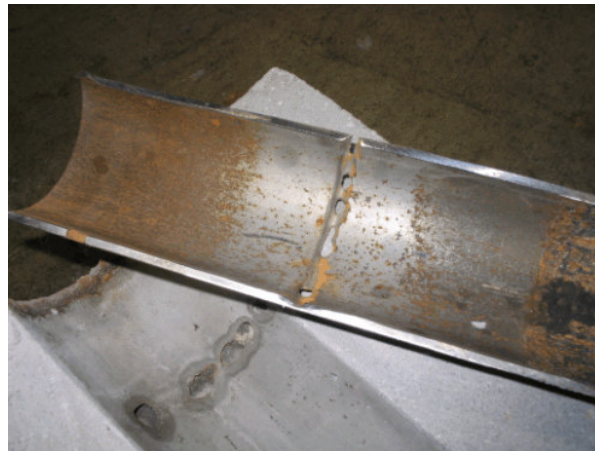
Fig 5: Slot cut into steel casing in yard test, using abrasive slurry.

A slotting tool was developed, tested and modified at CSIRO Petroleum in Melbourne. The tool jets were sized so that the steel casing could be cut in about 4 minutes. PVC and fibreglass casing required less time to cut than steel. Figure 5 shows a section of steel casing cut under these conditions. For this test, a short section of casing was encased in a concrete block and then cut using a sand-water slurry pumped at 120 lpm and 13.79 MPa (2000 psi) for 4 minutes. The openings shown in Figure 5 would provide more than enough access to the coal seam for carrying out hydraulic fracture stimulations. Higher cutting pressures are expected to reduce the slotting time further.

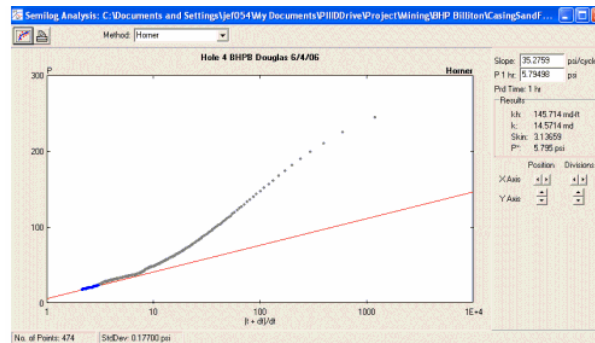
Fig 6: Analysis plot of the falloff data from the well test in Hole 4 at the 25m slot. This analysis gives the best estimate of reservoir pressure.

Figure 6 shows the analysis of the falloff data from the well test in Hole 4 at the 25 m slot. This analysis is considered to give the best estimate of reservoir pressure. Figure 7 shows a second analysis plot of the falloff data for the well test in Hole 4 at the 25 m slot which gives the best estimate of permeability.

The flattening of the falloff curve in the Horner plot is indicative of a test carried out by injecting water into an unsaturated seam. The early part of the curve (larger Horner time) where the slope is greater is used to obtain an estimate of the seam permeability. In later times (small Horner time) the pressure is affected by the low gas pressure in the reservoir and the slope tends to flatten and approach the reservoir pressure asymptotically. The intercept of this portion of the curve with a Horner time of 1 provides an estimate of the reservoir pressure. If more accurate estimates of permeability and reservoir pressure are required, the injection and falloff portions of the test should be extended to several hours each.

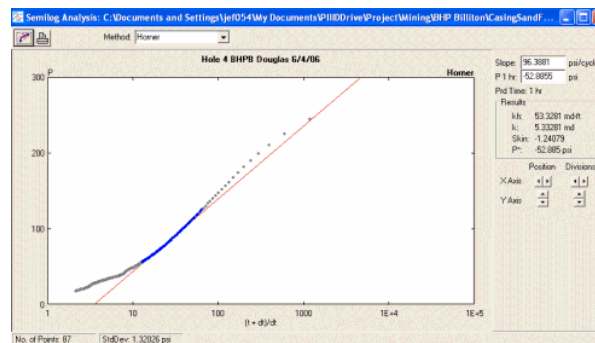
Fig 7: Second analysis plot of the falloff data for the well test in Hole 4 at the 25m slot. This analysis gives the best estimate of permeability.

Notwithstanding the short duration of the tests, permeability of about 5md and a reservoir pressure of about 34 kPa (5 psi) seem reasonable estimates based on the site location. It should also be noted that this analysis assumes radial flow conditions exist while such a short test is expected to take place almost wholly in a spherical flow period.
