Study on Rib Spalling Mechanism and Spalling Depth in Large Mining Height Fully-Mechanized Face

STUDY ON RIB SPALLING MECHANISM AND SPALLING DEPTH IN LARGE MINING HEIGHT FULLY-MECHANIZED FACE

The average depth of 1-2# coal seam is 240 m in the Shangwan coal mine, Shendong mining area. The large mining height using a fully-mechanized mining technology was applied in the working faces of the 1-2# coal seam in the 3rd panel. The large area of face spall occurred repeatedly during the mining process, which seriously affected the normal production of the working face. The "thin plate" mechanical

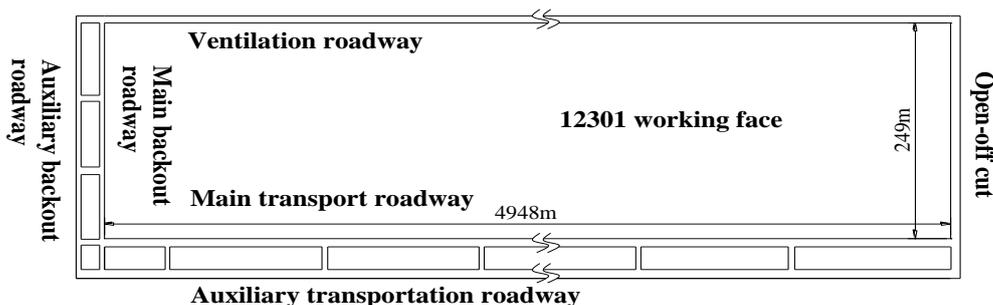
Figure 2: Roadway arrangement of LW 12301

LW12301 is the first working face of panel 3 in 1-2 coal seam, which is operated using a fully-mechanized longwall mining method. The mining height is 6.0 m, the face length is 249 m and the mineable advancing panel is 4948 m long. The roadway arrangement of LW12301 is shown in Figure 2. The thickness of the sandy mudstone immediate roof ranges from 0.63 m to 3.87 m. The thickness of the fine-sandstone main roof is 1.3~4.2 m and is the main component of sandstone. The thickness of immediate bottom is 0.56~2.11 m with mudstone easily softened with water. The site investigations revealed that the large area of face spall exploded into the working area several times during the periodic weighting with the fish scale like face appearance. The maximum depth of rib spall was 1.7 m, which decreased the normal shearer and hydraulic support efficiency and posed a huge threat to the working face production and workers safety. The rib spalling scene of LW12301 during first weighting is shown in Figure 3.

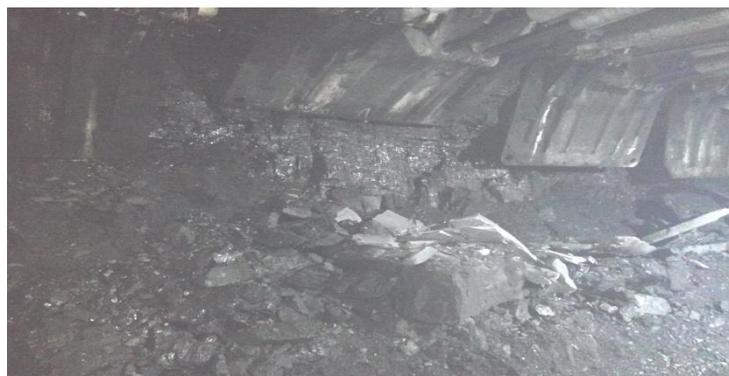
Figure 3: Rib spalling of LW12301 during first weighting

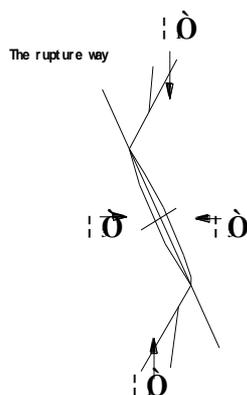
Figure 4: Rupture direction of crack tip under cyclic compressive load

Rib deterioration due to the large mining height at the working face is a complex mechanical process. The coal rib is not only influenced by the mining induced and tectonic stress, but also affected by some constrained effects of the deeper coal mass. From the perspective of fracture mechanics, the delamination fracture will occur when the tension or relative displacement between rib and deep coal mass reaches a certain limit. The deformation of the inelastic rib bearing segment continues to grow and the internal fissure damage within the ribside will accumulate. If the delamination fractures develop within the rib to inter-permeation, it is easy to reach rib instability in a large area. The interior coal fractures, under compressive stress, can rapidly expand causing rib failure along the parallel or biased maximum principal stress α_1 direction as shown in Figure 4. Rib failure can be simplified using the 'thin plate' model as shown in Figure5. Rib gradual deterioration damage characteristics are shown in Figure 6.

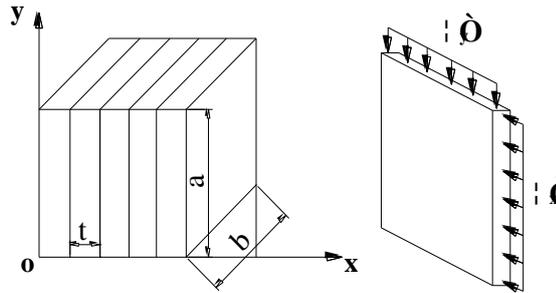
Figure 5: Thin plate force model of rib

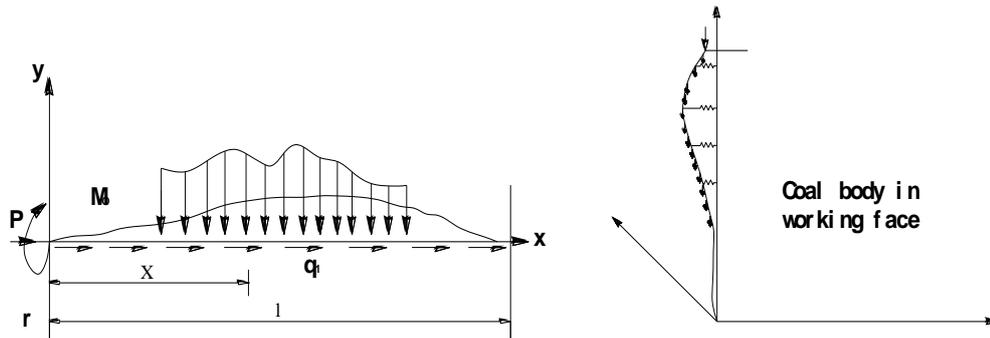
Figure 6: Rib progressive deterioration damage characteristic

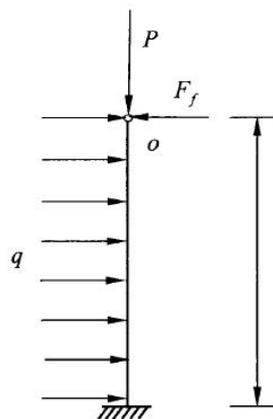
Figure 7: Simplified rib mechanical model

In Figure 7 q is the horizontal load, F_f is the friction resistance between coal seam and roof, P is the roof pressure, l is coal seam mining height, the rectangular coordinate system is built with the point o as the origin of coordinates, x is the vertical downward axis and y is the horizontal axis positive to the right. The simplified model of the large mining height rib is mechanically analysed as follows:

The rib of a large mining height working face bears the horizontal pressure from the front coal mass and the gravity stress of the overburden roof. The rib can be regarded as the statically indeterminate uniform beam (one end is clamped as support and the other end is simply supported). The rib geometry can be simplified to analyse the rib deflection produced in a horizontal direction. The gravity stress and the compression deformation in a vertical direction are ignored. The simplified model of the large mining working face rib is shown in Figure 7.

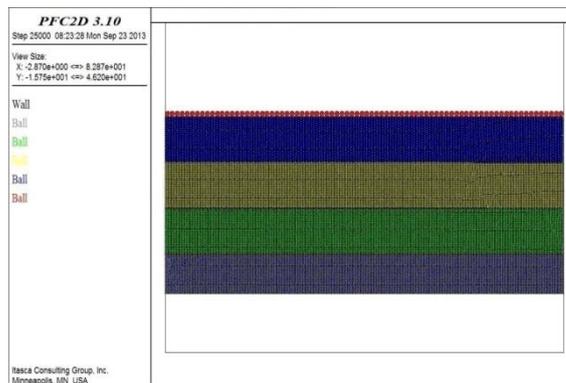
Figure 8: Graph of numerical analysis model

In order to analyse the rib spalling of LW12301, PFC^{2D} software was used to carry out the numerical simulation. The width of the model was 400 m and height is 80 m. The working coal face thickness was 6.0m and the dip angle was 0°. The geometric model as shown in Figure 8.

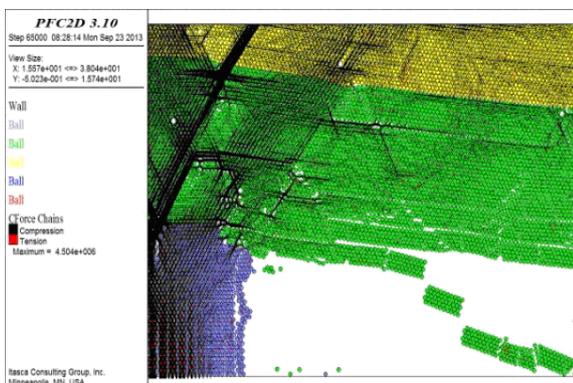
Figure 9: Peak abutment stress zone in front of LW12301

The stress constraint in front of LW12301 is shown in Figure 9. It is clearly observed that the peak abutment stress zone is 5.0m ahead of the working face. The scale of rib spalling is shown in Figure 10. With the working face advancing, the coal failure becomes tensile failure from shear failure and gradually develops inwards the rib which causes the instability of the coal wall, and the stable height is 4.5 m. In the comparatively stable area, the phenomenon of slight rib spalling occurs with the depth of rib spalling of 0.8 m. The more serious rib spall occurs 2.5 m below the roof level reaching 1.5 m in depth. The rib spall takes the shape of a triangle. The numerical simulation result is consistent with the theoretical result.

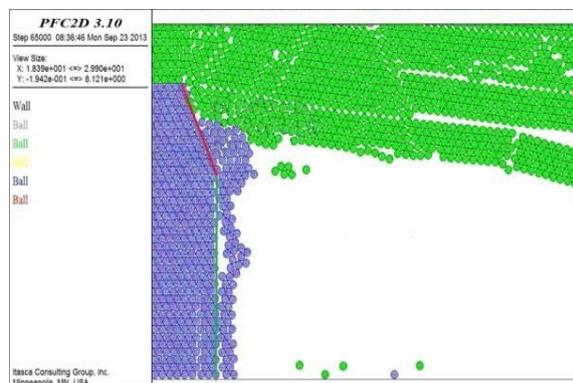
Figure 10: Rib spalling scale of LW 12301

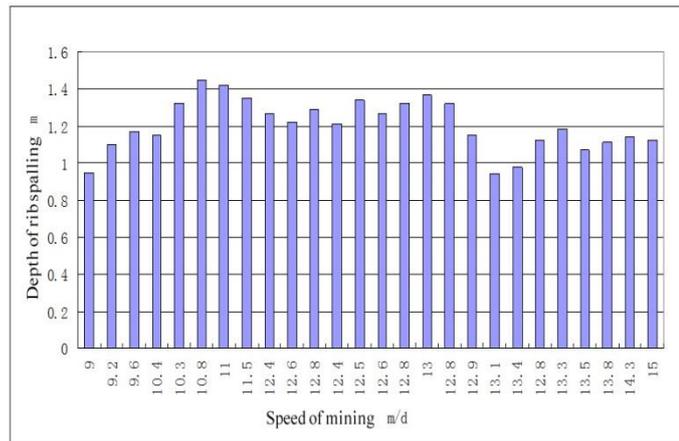
Figure 11: Depth of the working face rib spall (without periodic weighting)

During the excavation process of LW12301 in the Shangwan mine, the observation results of the rib spalling depth were statistically summarised and are shown in Fig.11 and.12. According to the field statistics, it was found that the advancing speed of the working face influenced the rib spalling. During the normal mining of LW12301, the depth of rib spalling firstly increased and then decreased and finally reached a stable level of 1.0m to 1.2m. During the periodic weighting of LW12301, the peak stress in front of the working face increased and moved forward, aggravating the rib spalling. The average depth of rib spall was 1.55m, and the maximum was 1.7m. The observation results are consistent with both the numerical simulations and the theoretical results.

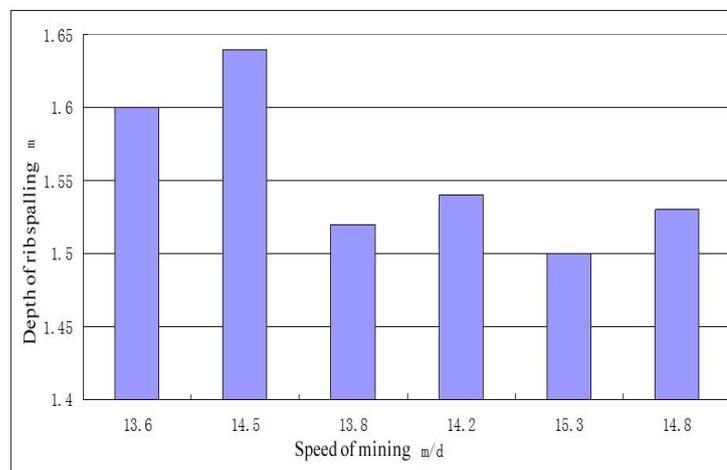
Figure 12: Depth of the working face rib spall (with periodic weighting)
