Sustainable solutions for exposed concrete surfaces to climatic influences - Within various regions: An industrial-geographic letter to civil-constructors

SUSTAINABLE SOLUTIONS FOR EXPOSED CONCRETE SURFACES TO CLIMATIC INFLUENCES – WITHIN VARIOUS REGIONS: AN INDUSTRIAL-GEOGRAPHIC LETTER TO CIVIL-CONSTRUCTORS

Cite this Article: Mahmood M. H. Alshammari, Ali k. M. Al-Nasrawi and Ali Jabbar Abdullah, Sustainable Solutions For Exposed Concrete Surfaces To Climatic Influences – within Various Regions: An Industrial-Geographic Letter To Civil-Constructors, International Journal of Civil Engineering and Technology (IJCIET), 10 (1), 2019, pp. 242–254.

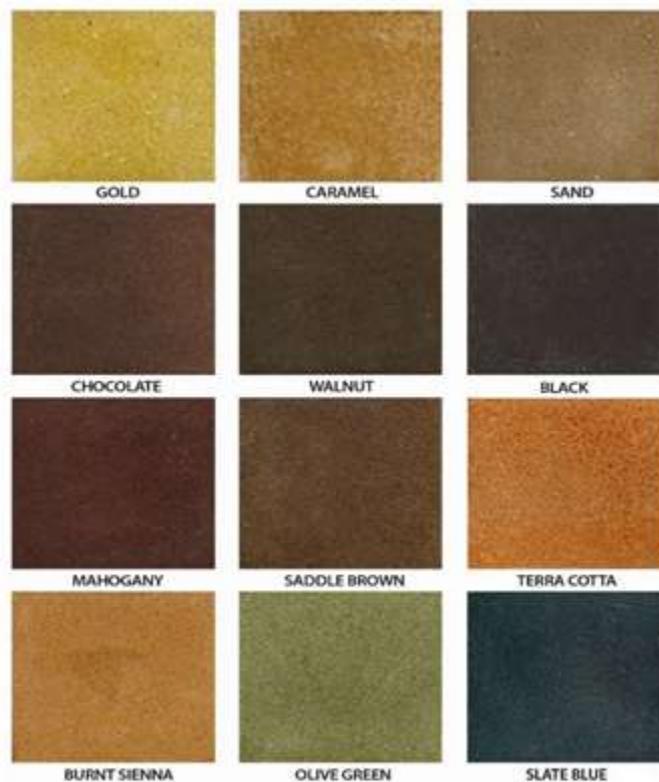
Figure 1. Concrete silicate colorant (Supplee Sr, 2003; Min'ko *et al.*, 2018).

Many simple-to-apply environmental treatments can be suggested which are suitable to solve a range of climate-related problems and are furthermore low-cost. Therefore, most of the concrete problems would benefit from environmental solutions in addition to repairing the damaged surfaces (Rizzo and Sobelman, 1989; Hardoy *et al.*, 2013; Kamei *et al.*, 2018). These solutions are environmentally friendly and improve the longevity of concrete surfaces using some recommended materials (Spiratos and Jolicoeur, 2000; Hardoy *et al.*, 2013), such as the concrete silicate colorant (Min'ko *et al.*, 2018), see Figure 1.

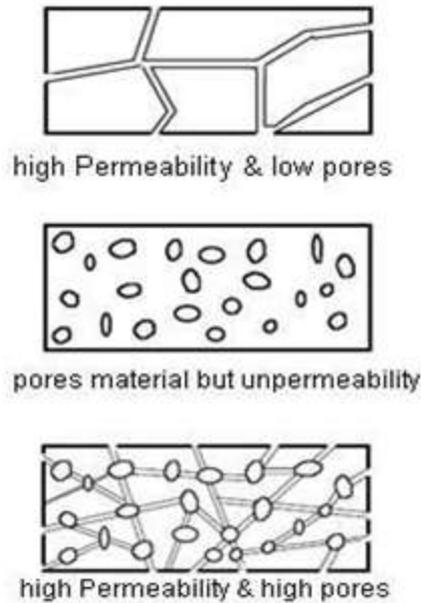
Figure 2. Permeability and pore types, different types are related to the effects of different temperature impacts on the concrete aggregate(Gallé, 2001).

In concrete material, the role of water has to be seen as a necessary ingredient for cement hydration reactions and as a variable that facilitates the mixing of the components of concrete during the construction stage from the beginning(Shetty, 2005). Gradually, (however, depending on weather conditions and thickness of a concrete layers or columns) all of the water will be evaporated from the concrete (through many ways including the capillary attributes) and will be lost(Gallé, 2001). This will leave the pores empty or unsaturated as tiny holes connect through microscopic channels (permeability) in different types (see figure 2).

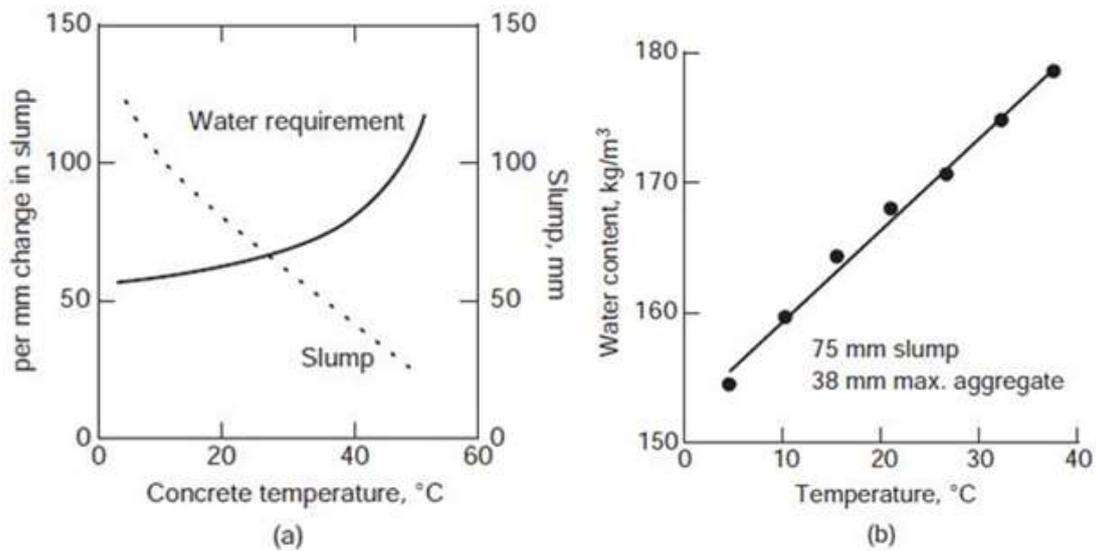
Figure 3. (a) The effects of concrete temperature on the slump and water requirement, (b) impacts of ambient temperature on the water requirement of concrete (source: report of ACI Committee 305 on hot weather concreting, ACI Mat. J., Vol. 88, No. 4, p. 422, 1991)

In terms of construction problems with structural concrete, the American Concrete Institution-ACI committee since 1991 defines hot weather as any combination of high air temperature, low relative humidity, and wind velocity tending to impair the quality of fresh softness, hardened concrete or otherwise resulting in abnormal properties(Committee, 2005). In addition to increasing slump loss, stretching and contraction-shrinkage cracking(Baluch *et al.*, 2002), and the decrease of settling time in fresh concrete, hot weather increases the mixing water requirement for a given consistency (figure 3) and creates difficulty in holding the air in an air-entrained concrete mixture(Michael, 1963). Retempering of mushy/soft concrete is frequently necessary for hot weather(Michael, 1963). At times, this causes adverse effects on strength, durability, stability, and appearance of the hardened concrete surface(Malhotra, 1976; Mays, 2003).For example, the concrete that dried within a higher moderate temperature than the ambient normally develops an early higher strength after 28 days only. The strength is usually lower than the same concrete placed and cured at a relatively low temperature.

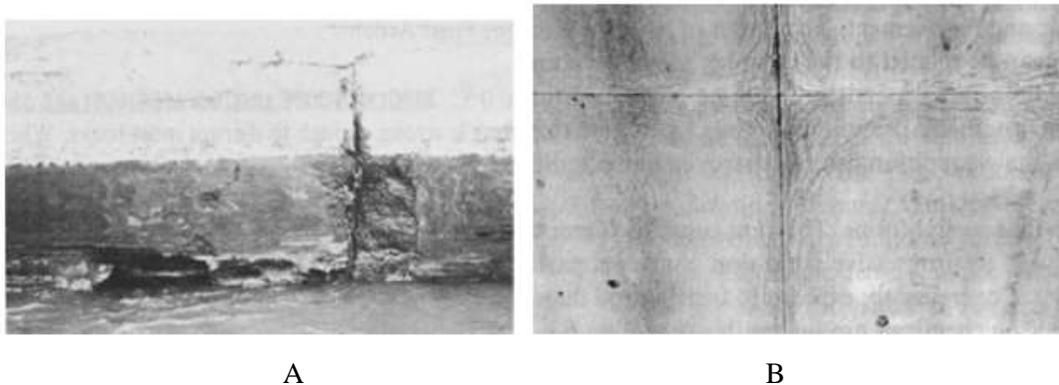
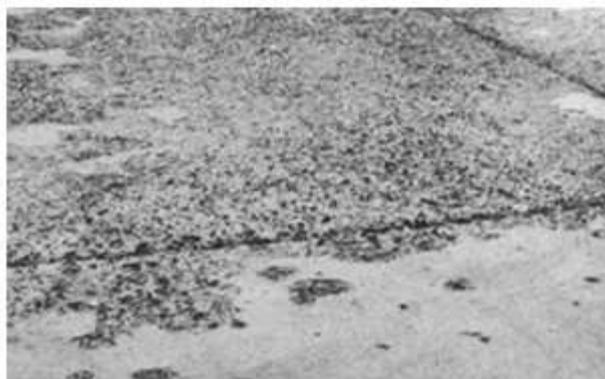
Figure 4. Different effects of concrete deterioration due to frost action exemplarily shown for (a) pavements, (b) retaining walls, and (c) bridge decks (López *et al.*, 2016; Kamei *et al.*, 2018).

In cold climates, the causes of deterioration of concrete surface have been linked to frost impacts. In such environments, damage to concrete can occur on pavements, retaining columns/walls, bridge decks, or railings (Figure 4) (Hardoy *et al.*, 2013). Such damages are attributed to fluctuating freezing action (variability of freezing and melting cycles), which is one of the major problems requiring substantial expenditures for the repair and even replacement of structures in some cases (Rizzo and Sobelman, 1989; Kamei *et al.*, 2018).

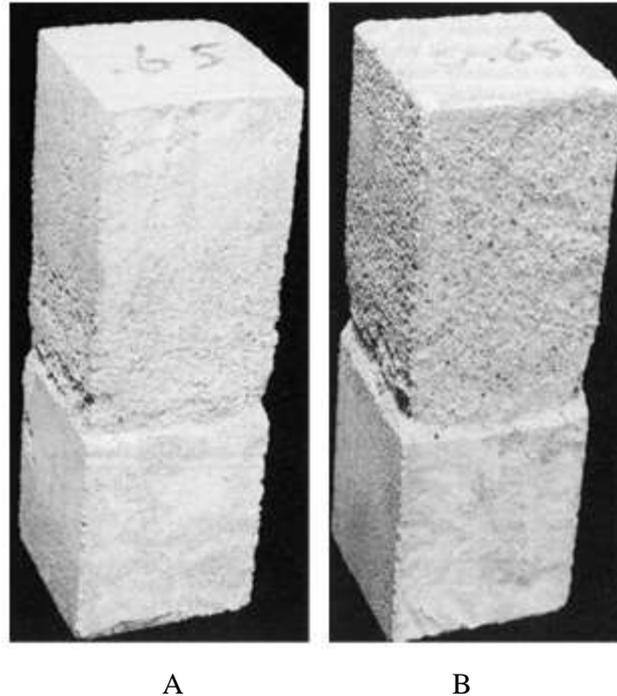
Figure 5. Cracks, peeling and corrosion are curving around the four corners of the slab to D shape(Mehta and Gerwick, 1982; Talbot and Talbot, 2018).

Frost related damages in concrete can take several forms. The most common is cracking and peeling, mostly starting on the concrete surface and caused by progressive expansion of the cement paste/porous-cells by repeated freezing and melting cycles (Mehta and Monteiro, 2006). Coarse materials in concrete components which allow for more permeability and porosity within the concrete cells enhance the likelihood of cracking to occur (Baluch *et al.*, 2002). Notably, parallel to joints and edges, the concrete body is eventually acquiring a pattern resembling a large capital letter “D”. The term D-cracking describes this type of cracking (figure 5) (Baluch *et al.*, 2002; Mays, 2003; Kamei *et al.*, 2018).

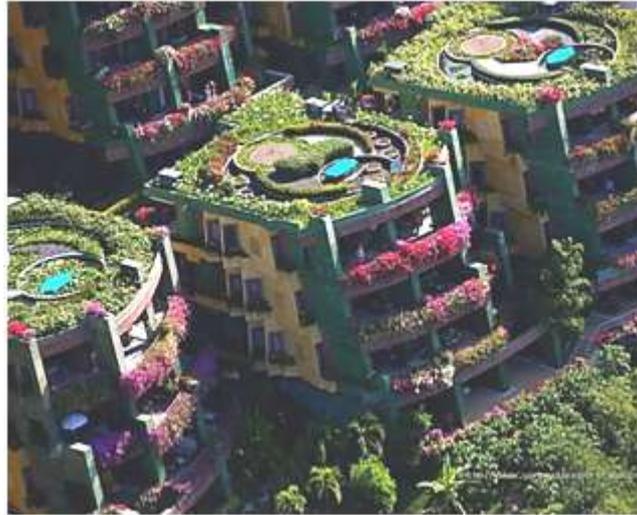
Figure 6 Vegetation canopy solution, by planting/cultivation native-green covers on top, sides and around buildings within high-temperature regions.

environmental attributes to absorb the solar radiation influences (Akbari *et al.*, 2001). Whereas, higher buildings can plant the vegetation canopy on the top, side, and balconies as shelves (see figure 6).
