## Field Testing and Reliability Assessment of Video Based Fire Detection in Coal Mining and Coal Handling Environments

# FIELD TESTING AND RELIABILITY ASSESSMENT OF VIDEO BASED FIRE DETECTION IN COAL MINING AND COAL HANDLING ENVIRONMENTS

*Abstract:* Previous laboratory test results and numerical modelling showed that Video Based Fire Detection (VBFD) offers a means of providing earlier fire detection compared with traditional carbon monoxide (CO) detectors in typical Australian underground mines. Additionally, from a reliability viewpoint compared with VBFD, CO detectors are subject to sensor drift and insensitivity as a result of contamination of the CO sensor device as reported by the National Institute of Occupational Safety and Health (NIOSH). The reliability of VBFD in an underground mining environment was unknown until field-testing as the final part of this research program was carried out.

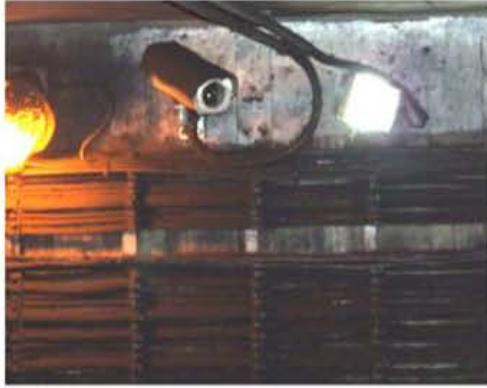
Figure 1: VBFD CCTV in Coal Staithe Transfer Area

1. Coal Staithe Transfer Area; (Refer 1)
2. Coal Staithe conveyors; (Refer 2)
3. Inclined conveyors to coal bunkers; (Refer 3)
4. Coal staithe drive pulleys; (Refer 4)
5. Coal bunkers; (Refer 5)
6. Coal bunker walkways; (Refer 6)
7. Coal bunker conveyor offload areas; and
8. Coal bunker tail pulleys.

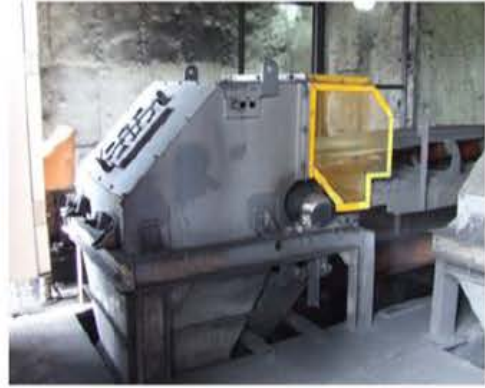
Figure 4: Coal Staithe Conveyor Belt Drive Pulley

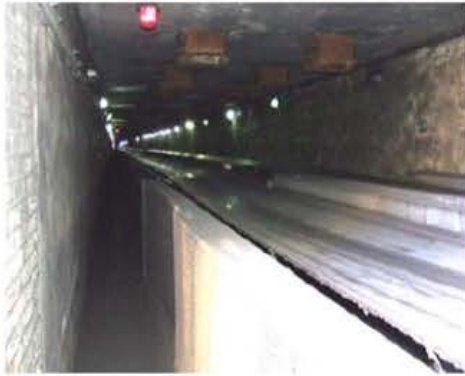
Figure 2: Coal Staithe Conveyors

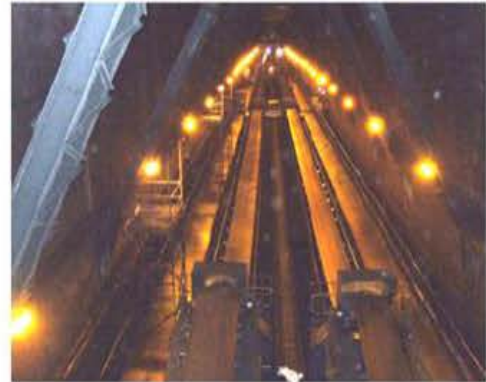
Figure 5: Coal Bunker

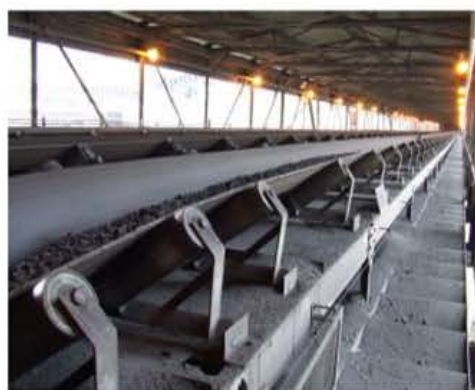
Figure 3: Inclined Conveyor from Coal Bunker

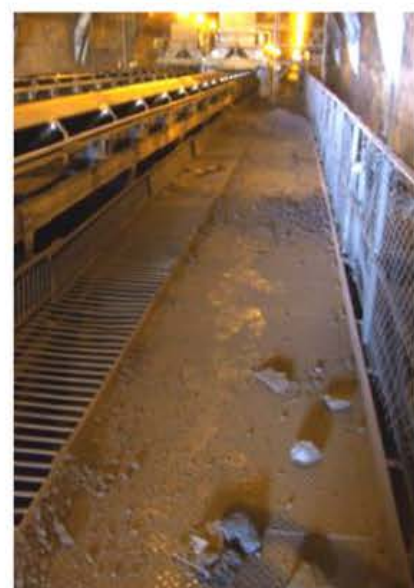
Figure 6: Coal Bunker Walkway

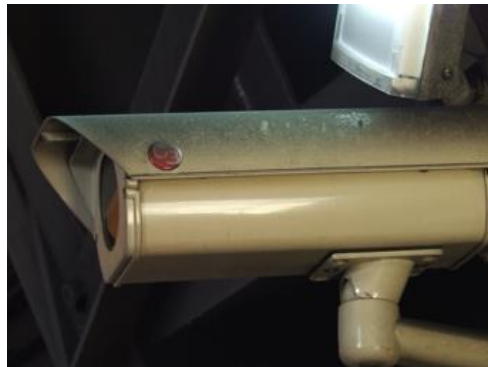
**Figure 7: Typical Dust Accumulation on VBFD CCTV Camera**

camera lenses are 'dry' cleaned at Arnot Power Station using a domestic feather duster applied every two (2) weeks. An image showing the level of surface dust accumulation on VBFD cameras in typically 'dirty' locations is provided in Figure 7 whilst the typical view from a camera with an obscured lens achieving 55.79% visibility, is shown in Figure 8.

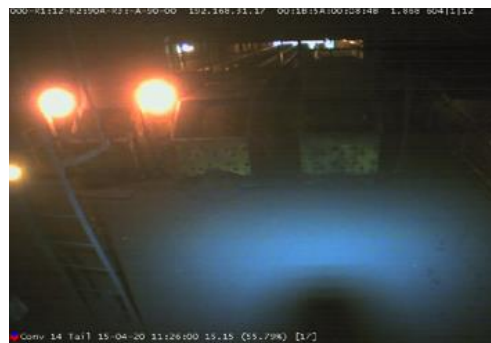
**Figure 8: Obscured view from VBFD camera with 55.79% (Dirty Lens) visibility**
