Influence of soil clogging on the performance of jute fibre drains installed in Ballina clay

Nguyen, T. T., Indraratna, B. & Carter, J. P. (2019). Influence of soil clogging on the performance of jute fibre drains installed in Ballina clay. 13th Australia New Zealand Conference on Geomechanics (pp. 797-802). Sydney, Australia: Australian Geomechanics Society.

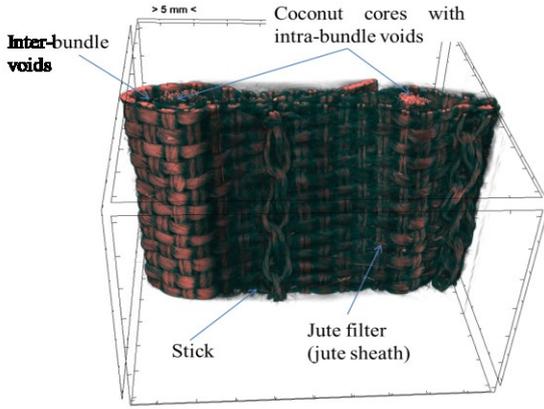
Figure 1 Jute BPVD under micro-CT scanning

While coconut cores are used to shape and strengthen the drain, the jute geotextile acts as an external filter to maintain the internal porous system of the BPVD. Figure 1 shows the structure of the drain used in the current study, as identified from micro-CT scanning and 3 dimensional reconstruction.

Generally a BPVD is made by arranging individual natural fibres in a certain format that can include either circular or banded shapes. Jute and coconut are the most preferred fibres used to fabricate these drains, which is why they are usually named as natural fibre drains or jute fibre drains. In the current study, the behaviour of a band-shaped BPVD, which includes 4 coconut (coir) cores wrapped by a jute sheath, is studied (Figure 1).

It is interesting to note that the drain porosity is composed of two types of voids; namely the inter-bundle and intra-bundle voids (Figure 1). Intra-bundle void means the space allocated within a fibre bundle; this includes voids between single fibres making the jute and coconut bundles. Inter-bundle voids are those distributed between different bundles. Because of the differences in structure between these two void types, they respond differently to confinement, which is explained in detail in the following sections.

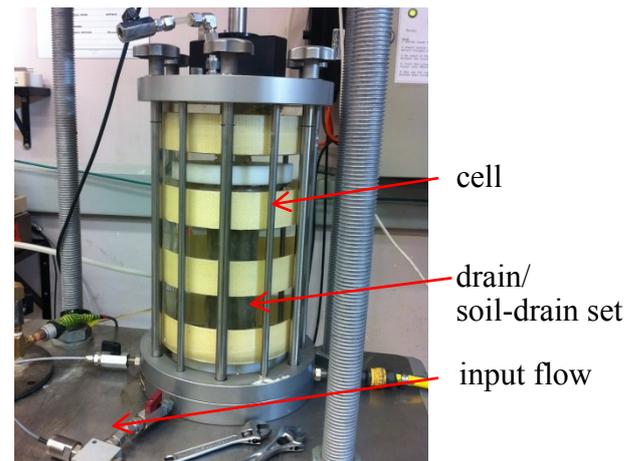
Figure 2 Measuring the discharge capacity of the soil-drain sample under cell confining pressure

(ii) Discharge capacity test: after confinement (and full soil consolidation), the soil-drain set was subjected to a discharge capacity test. Flow under a controlled water head was created through the drain. Hydraulic heads were recorded at the inlet and outlet of the drain via manometers. Different water heads (i.e., hydraulic gradients) were applied and the cor-

responding discharge volume was measured at the outlet of the drain. A hydraulic gradient varying from 0.1 to 1.0 was used. Note that the discharge volume was only taken once steady state flow was reached for each level of hydraulic gradient. Further details of this test can be found in Nguyen et al. (2018). Soil particles washed along with the flow were found during the test, indicating some soil entering and clogging the drain.

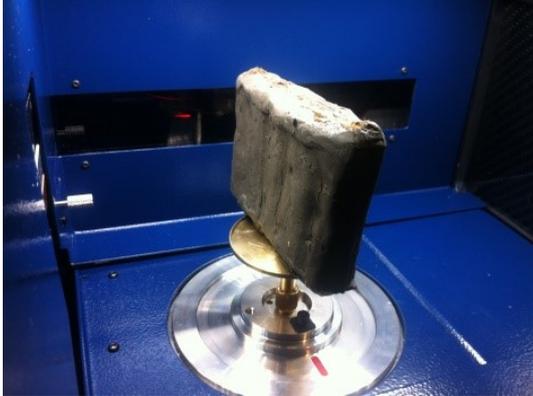
Figure 3 Soil-drain sample after confinement being scanned in the micro-CT chamber

(iii) Post-processing of soil-drain sets: following the discharge capacity test was an examination of how soil particles had changed the porous structure of the drain. The sample including the soil and the drain in its intact state was subjected to micro-CT scanning (Figure 3) which was able to explore the interior structure of the sample without disturbance. Unlike other conventional microscopic observations such as optical microscopic scanning, micro-CT scanning can capture the otherwise invisible structural characteristics of a porous object based on the difference in X-ray energy absorption of the different materials making up the object. This enabled the interior of the soil-fibre drain systems to be detailed because of the difference in response of the soil and the natural fibres (jute and coir) to X-ray radiation. Images from the scanning continued to be processed for quantitative information. In this study, a CT scanner named SkyScan 1275 with a voxel resolution of 4 μm was used.

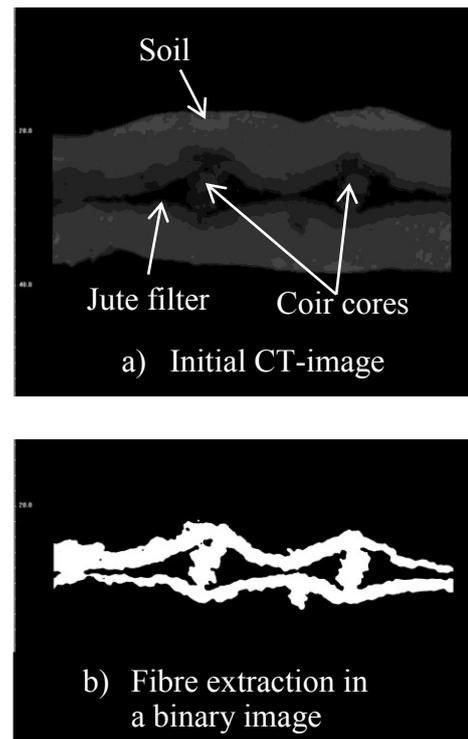
Figure 4 CT-image of drain-soil set and post-processing to extract fibre regions in a binary image

Figure 4a shows an example of raw CT-images for a drain-soil system without processing. Soil which has a higher density is present in the brighter areas compared to the jute and coir fibres. After a number of image processing steps, the fibres including the jute and coir were separated (Figure 4b), which enabled the area (and volume in 3D) of the fibres to be calculated. By accumulating a series of consecutive CT-images, the volume of fibres could be obtained. The same procedure was applied to soil, individual fibres as well as bundles of fibres with and without soil to obtain their structural and porous characteristics.

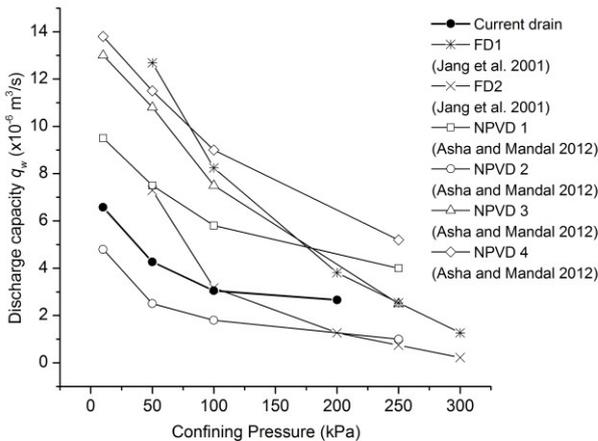
Figure 5 Discharge capacity of the current BPVDs compared to other drains

Figure 5 presents the discharge capacity of the current BPVDs in comparison to other natural fibre drains used in previous studies. Note that the latter

tests do not include drains confined by soil. The discharge capacity of the drain used in the current study is about $7 \times 10^{-6} \text{ m}^3/\text{s}$ at low confining pressure (i.e., 10 kPa), which agrees well with previous data. The differences in discharge capacity reported by different studies are understandable because of the varying drain structures and testing apparatuses. In all cases the discharge capacity reduces significantly as the confining pressure increases to 50 kPa, indicating considerable reduction in porosity of the drain. However at a higher level of confinement, the reduction in discharge capacity becomes insignificant. In particular when the confining pressure varies from 100 to 200 kPa, the discharge capacity is almost unchanged. This behaviour is somewhat different from some previous studies, e.g., Jang et al. (2001) where their drains still show considerable reduction in discharge capacity at a pressure larger than 100 kPa. This is probably because Jang et al. (2001) used weaker BPVDs than the current study. For example FD2 used by Jang et al. (2001) has only 3 coconut cores which play an important role in resisting confinement, resulting in a more significant reduction in discharge capacity when increasing p_c .

The discharge capacity q_w of the current BPVDs can satisfy the requirements for assisting soil consolidation to a certain degree, according to Chu et al. (2004). For example, with respect to a treatment depth of 20 m and a soil permeability $k_s = 1 \times 10^{-10} \text{ m/s}$, the required value of q_w is estimated to be about $2 \times 10^{-6} \text{ m}^3/\text{s}$ which is lower than the value of q_w measured in this study. However considering a soil having a higher permeability, i.e., $k_s = 1 \times 10^{-9} \text{ m/s}$, a larger discharge capacity which exceeds the current measured q_w is needed. But note that soft soil in the field, such as the Ballina clay (Pineda et al. 2016), usually has a value of k_s smaller than $1 \times 10^{-10} \text{ m/s}$ at depths greater than 7 m. Hence proper attention should be paid to drain design when using this type of drain to assist soil consolidation.

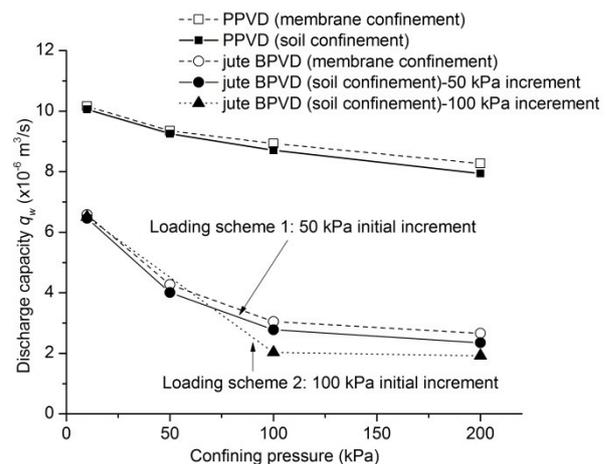
Figure 6 Discharge capacity of the current BPVDs compared to other drains

The discharge capacity measured for the drain confined by soil is shown in Figure 6, together with a comparison to that without soil confinement. The figure indicates the influence that the soil confinement and loading scheme have on the drain discharge capacity. In particular, the discharge capacity decreases from 4.3×10^{-6} to $4.0 \times 10^{-6} \text{ m}^3/\text{s}$ at a value of p_c of 50 kPa due to soil confinement when considering the first loading scheme. This reduction is insignificant. However, a larger initial increment in the confining pressure, i.e., from 10 to 100 kPa, as adopted in the loading scheme 2, results in greater degradation in discharge capacity, viz., a decrease to $2.78 \times 10^{-6} \text{ m}^3/\text{s}$ (35% loss) at 100 kPa. Further increase in confining pressure (i.e., from 100 and 200 kPa) does not cause much further reduction in discharge capacity. This probably indicates that a state is reached where additional soil particles cannot be compressed into the drain despite the increasing confining pressure. At low confining pressure the drain performance is not degraded by soil clogging.

Figure 6 also compares the discharge capacity of BPVDs with conventional polymeric PVDs (PPVDs). PPVDs generally have much larger discharge capacity, and they are also quite resistant to soil clogging because of their very fine filter (i.e., Apparent Opening Size (AOS) $< 75 \mu\text{m}$). It is interesting to note that while the PPVDs do not have significant reduction in their discharge capacity when p_c increases, BPVDs are very sensitive to confining pressure. This is understandable since BPVDs are composed of individual fibres with large internal pores which are very vulnerable to change when the drains are compressed. Microscopic observations and analyses described in the following sections of this paper will further clarify this aspect of their behaviour.

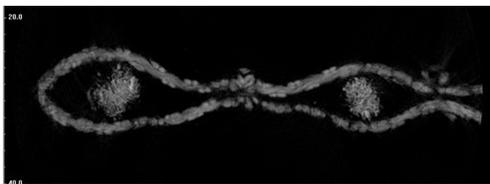
Figure 7 Fresh drain compared to confined drain

Figure 7 illustrates how the drain volume changed under compression, in this case resulting in approximately 22% reduction in the drain porosity. In particular, the drain porosity decreased from 0.86 initially to 0.64 after being confined at 50 kPa. It is interesting that the major reduction is contributed by the decrease in inter-bundle voids, which varied due to fibre rearrangement under confinement. However, the larger confining pressures (i.e., 100 and 200 kPa) only reduced the porosity by about a further 9.4%, making the discharge capacity almost constant at these levels. It is important to note that porosity is the major parameter determining the hydraulic conductivity of fibre drains (Nguyen and Indraratna 2016).

Fresh drain (0 kPa)

Confined drain (50 kPa)

Post-processing of CT-images of drain samples after a discharge capacity test revealed that the drain porosity reduced considerably as the confining pressure increased to 50 kPa.

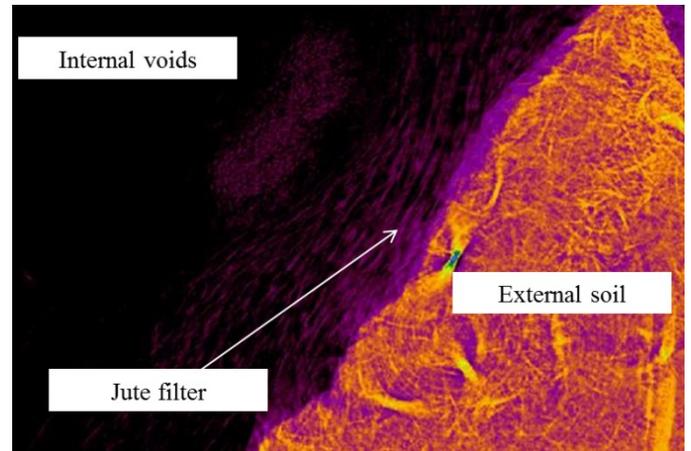
Figure 8 Jute filter-soil interaction after 50 kPa confinement (load scheme 1) examined under micro-CT scanning

Analyses of the drains confined in soil showed that the soil clogged the drains to different degrees depending on the loading scheme. Very little soil entered internal spaces of the drain in the loading scheme 1, while it deposited in those regions considerably in the loading scheme 2, resulting in a larger reduction in porosity. Porosity analysis based on micro CT-scanning showed that the loading scheme 1 in fact caused less than 5% reduction in total porosity of the drain, leading to insignificant changes in drain discharge capacity compared to that without soil confinement. The major contribution to this reduction was the decrease in porosity of the jute bundles making up the drain filter, which was the external layer interacting directly with the soil. The internal voids were almost unchanged by soil confinement in this case. In the loading scheme 2, a significant amount of soil was found within inter-bundle voids because the jute filter could not prevent soil penetrating into these internal regions at the

larger initial increment in confining pressure (i.e., 100 kPa compared to 50 kPa in the scheme 1). A larger initial pressure caused more soil penetration because the soil behaved much like a liquid at the beginning of loading (initial water content $w = 95\%$), while subsequent pressure increases did not lead to much soil clogging as the soil had already been consolidated considerably after the first stage of confinement.
