Causes of Overbreak in Tunneling: A case study of the Alborz Tunnel

Mohammad Farouq Hossaini, Mohammad Mohammadi, Jebreil Ghadimi and Alireza Abbasi, Causes of Overbreak in Tunneling: A case study of the Alborz Tunnel, in Naj Aziz and Bob Kininmonth (eds.), Proceedings of the 16th Coal Operators' Conference, Mining Engineering, University of Wollongong, 10-12 February 2016, 127-131.

CAUSES OF OVERBREAK IN TUNNELING: A CASE STUDY OF THE ALBORZ TUNNEL

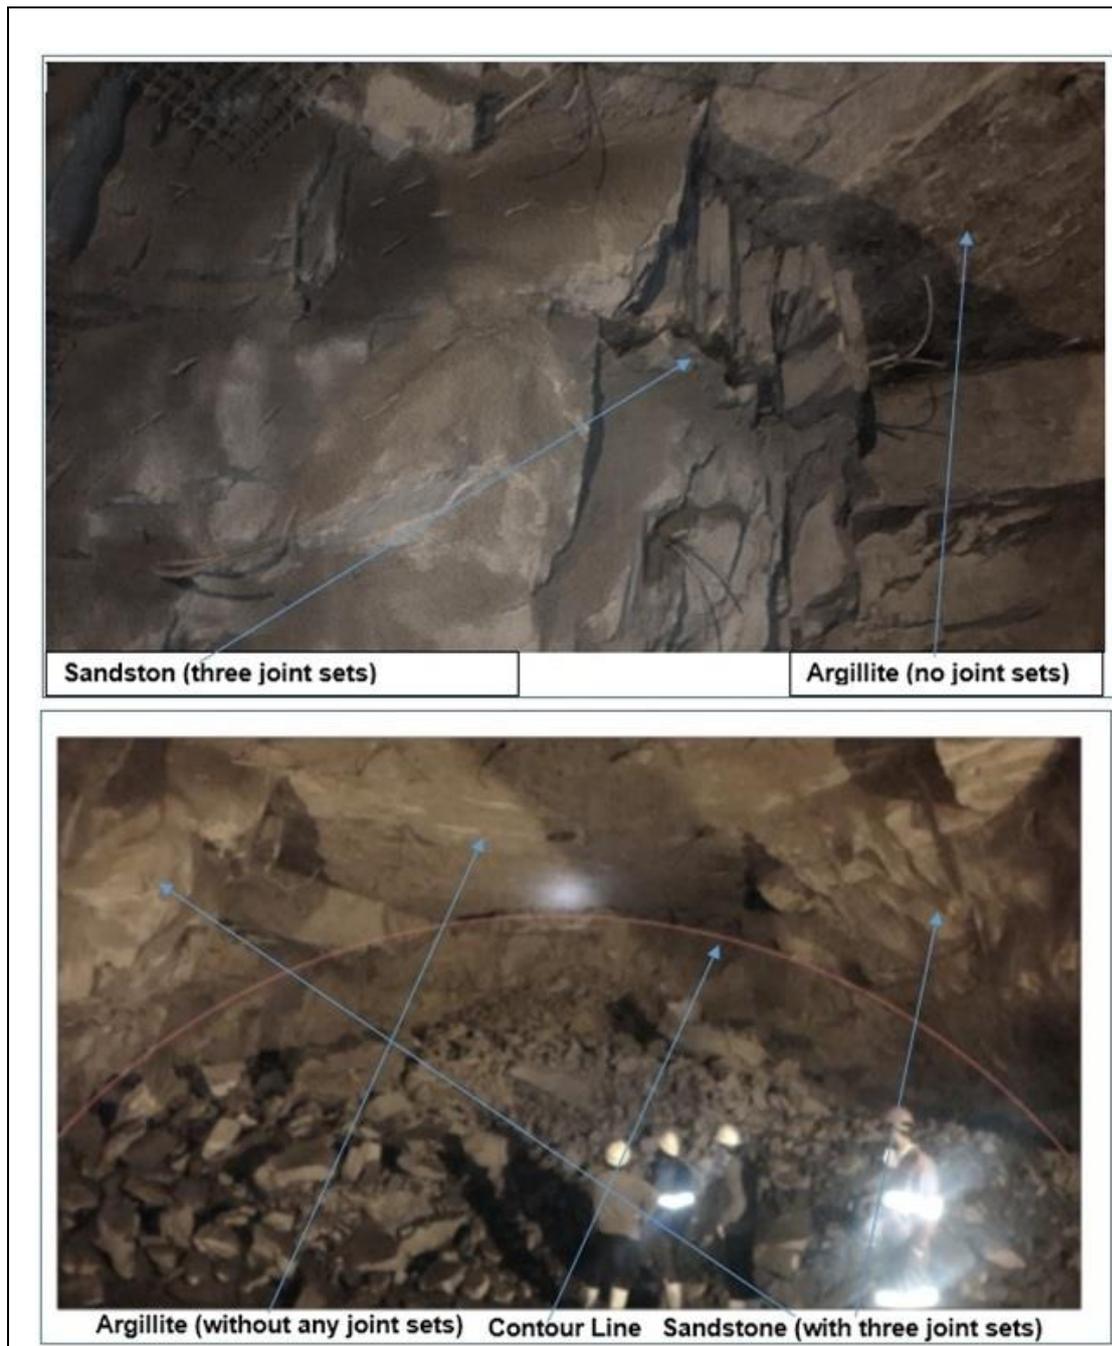
Figure 2: Argillite and sandstone layers along with disconformity surface

The main reason for the occurrence of excessive overbreak in the Northern face of the Alborz Tunnel in the study area is due to the existence of a disconformity surface just above the tunnel contour as depicted in Figure 2. The current excavation face is 635 metres into the tunnel from the Northern portal. However, the occurrence of overbreak which led to discovery of the disconformity surface started from 575 metres into the tunnel from the Northern Portal as shown in Figure 3.

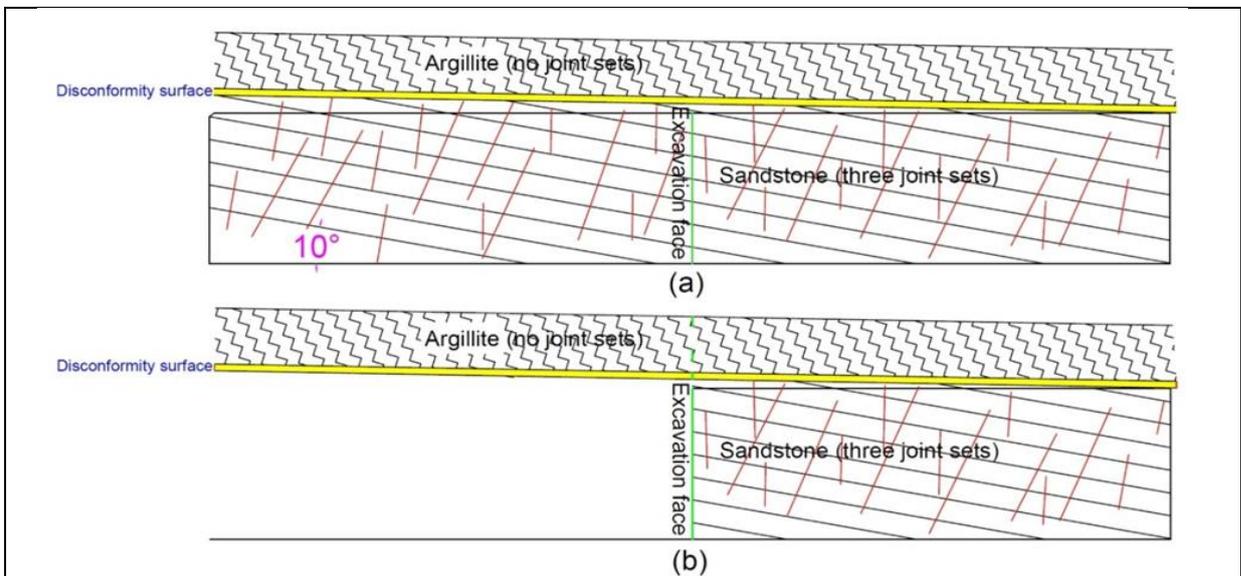
Figure 3: a) Existence of disconformity surface just above the tunnel contour b) Occurrence of excessive overbreak due to existence of disconformity surface above contour line

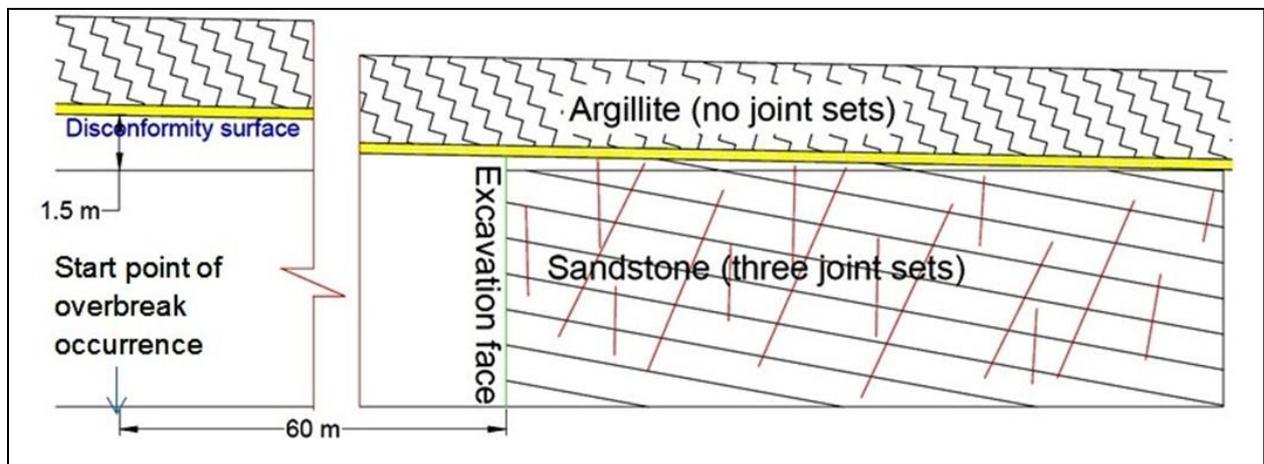
Figure 4: the start point of overbreak occurrence

Due to the dip and dip direction of the disconformity surface, the occurrence of overbreak in the start point is almost 1.5 metres above the contour line of the tunnel (Figure 4) and decreases gradually till the point where the disconformity surface reaches the contour line of the tunnel.

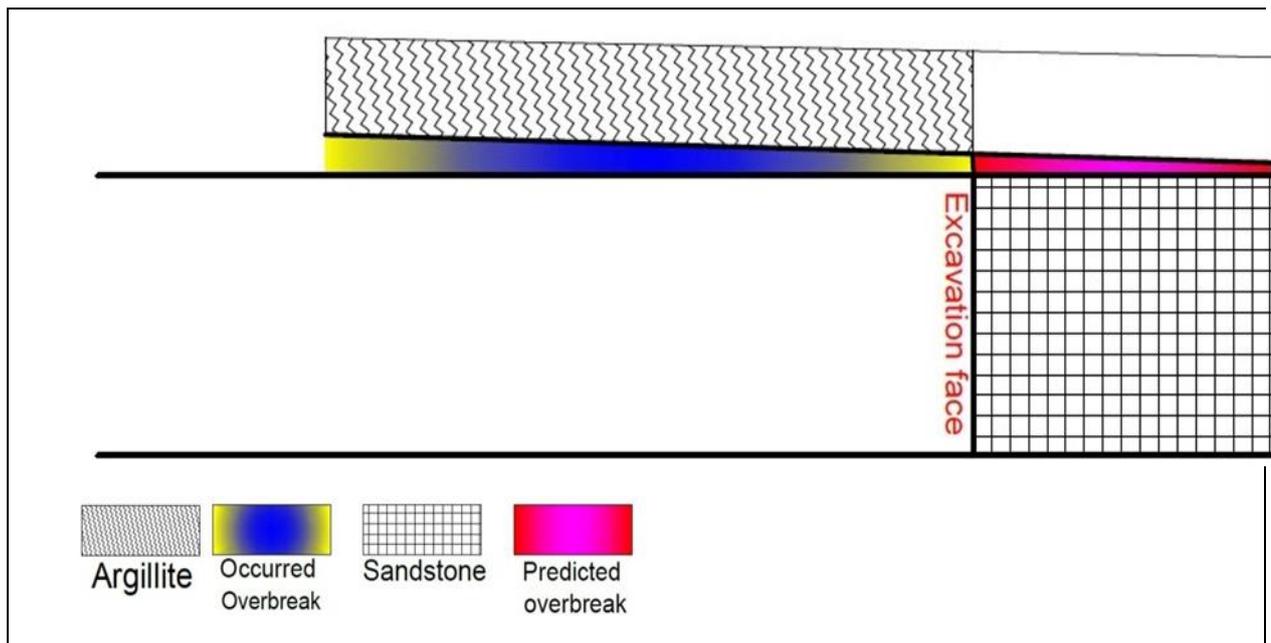
Figure 5: Predicted overbreak in the first case scenario

The distance of the surface of the disconformity from the contour line (overbreak area) is gradually decreasing with respect to the dip of the disconformity surface. Therefore, the first scenario can be the gradual decrease of overbreak area as the excavation face advances. However, there will be overbreak occurrences till the surface of disconformity reaches the contour line. Then, the main problem will be the existence of a weak layer of argillite in the tunnel crown. Finally, the argillite layer will pass through the contour line to gradually climb down the excavation face till it disappears. The occurrence of overbreak in this possibility is shown in Figure 5. The second scenario is that the argillite layer could be the bottom of a fold which means that the argillite layer is going to gradually increase its distance from the contour line causing a gradual increase of overbreak as the excavation advances. In this case, the exact values of overbreak may occur in reverse order (gradual increase) from the axis of the fold till the argillite layer separates from the contour line by 1.5 metres or more. However, this possibility is very unlikely to happen as there are no joint sets in the argillite layer.
