# Field Testing and Reliability Assessment of Video Based Fire Detection in Coal Mining and Coal Handling Environments

Frank Mendham, David Cliff and Tim Horberry, Field Testing and Reliability Assessment of Video Based Fire Detection in Coal Mining and Coal Handling Environments, in Naj Aziz and Bob Kininmonth (eds.), Proceedings of the 16th Coal Operators' Conference, Mining Engineering, University of Wollongong, 10-12 February 2016, 443-450.

# FIELD TESTING AND RELIABILITY ASSESSMENT OF VIDEO BASED FIRE DETECTION IN COAL MINING AND COAL HANDLING ENVIRONMENTS

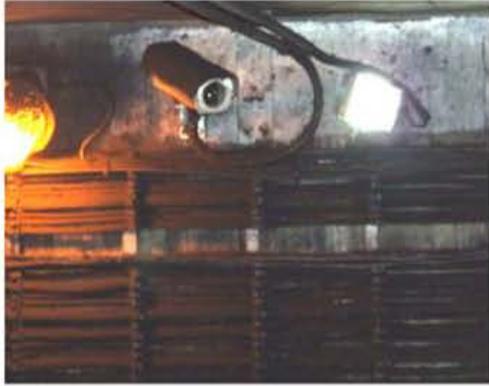
Figure 1: VBFD CCTV in Coal Staithe Transfer Area

1. Coal Staithe Transfer Area; (Refer 1)
2. Coal Staithe conveyors; (Refer 2)
3. Inclined conveyors to coal bunkers; (Refer 3)
4. Coal staithe drive pulleys; (Refer 4)
5. Coal bunkers; (Refer 5)
6. Coal bunker walkways; (Refer 6)
7. Coal bunker conveyor offload areas; and
8. Coal bunker tail pulleys.

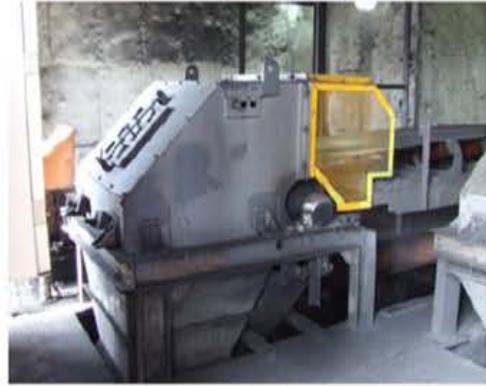
Figure 4: Coal Staithe Conveyor Belt Drive Pulley

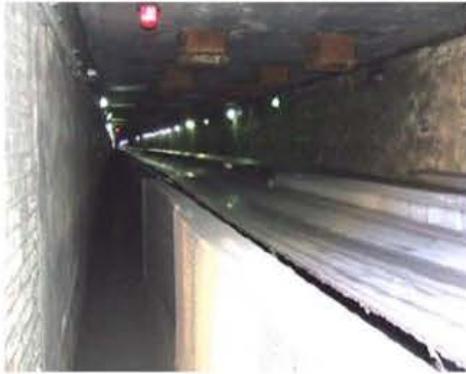
Figure 2: Coal Staithe Conveyors

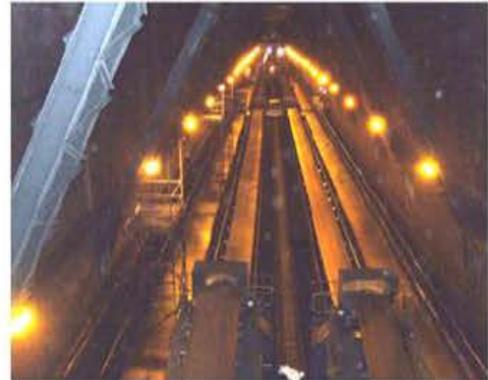
Figure 5: Coal Bunker

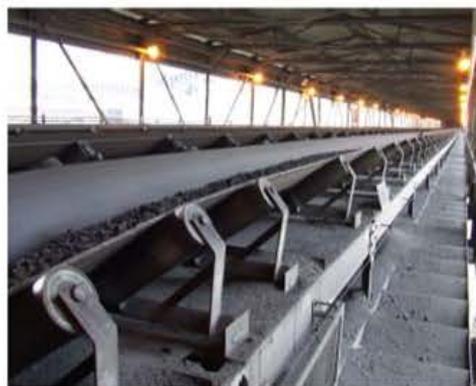
Figure 3: Inclined Conveyor from Coal Bunker

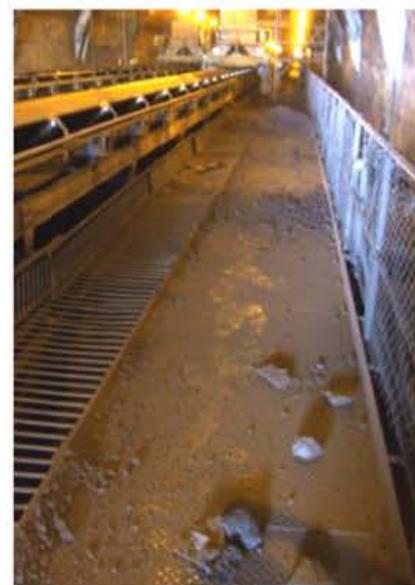
Figure 6: Coal Bunker Walkway

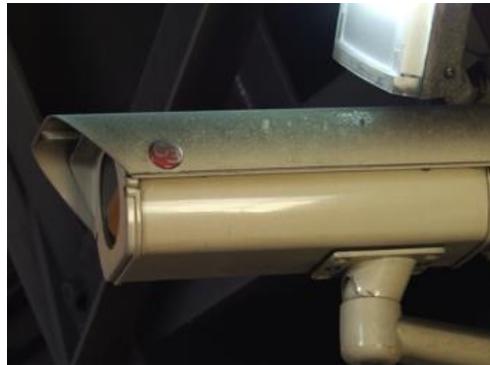
**Figure 7: Typical Dust Accumulation on VBFD CCTV Camera**

If not managed, dust contamination of the VBFD camera lenses will cause them to fail to detect a source of smoke, however this is countered by the VBFD analytics generating user programmable warning alarms to the controllers advising that lens obscuration is nearing a threshold and maintenance intervention (cleaning) of the VBFD camera lens or the camera-housing lens is required. All VBFD

camera lenses are 'dry' cleaned at Arnot Power Station using a domestic feather duster applied every two (2) weeks. An image showing the level of surface dust accumulation on VBFD cameras in typically 'dirty' locations is provided in Figure 7 whilst the typical view from a camera with an obscured lens achieving 55.79% visibility, is shown in Figure 8.

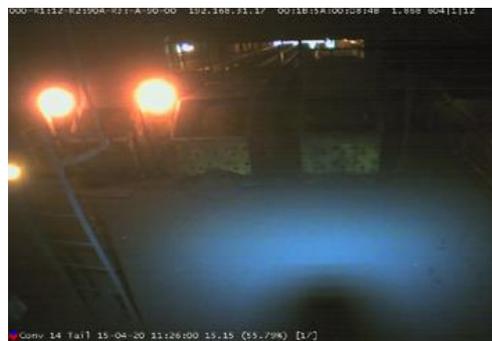
**Figure 8: Obscured view from VBFD camera with 55.79% (Dirty Lens) visibility**
