# Field assessment of ballasted railroads using geosynthetics and shock mats

Nimbalkar, S. & Indraratna, B. (2016). Field assessment of ballasted railroads using geosynthetics and shock mats. *Procedia Engineering*, 143 1485-1494.

# Field Assessment of Ballasted Railroads using Geosynthetics and Shock Mats

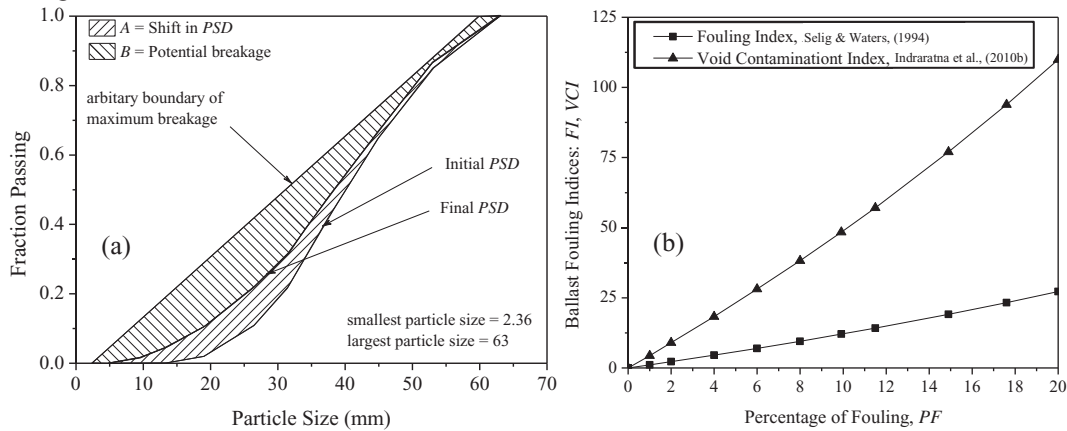
**Figure 1:** Evaluation of (a) BBI (data sourced from Indraratna et al., 2005), (b) VCI (data sourced from Tennakoon et al., 2012).

conventional *PSD* plot. The value of *BBI* can be determined by using the simple non-dimensional ratio termed as  $BBI = A/(A+B)$ . The parameter *A* is defined as the area between initial *PSD* and final *PSD*. *B* is the potential breakage which is defined as the area between the arbitrary boundary of maximum breakage and the final *PSD*.

Fouling material is defined as the material passing the 9.5 mm sieve (Selig and Waters, 1994). The fouling index (*FI*) is defined as the summation of  $P_{4.75}$  and  $P_{0.075}$ , where,  $P_{4.75}$  and  $P_{0.075}$  are percentages by mass of material passing the 4.75 mm and 0.075 mm sieve, respectively. A more appropriate volume based parameter defined as Void Contaminant Index (*VCI*) can be used as a reliable estimate of fouling. It incorporates effects of void ratio, specific gravity and gradation of fouling material and ballast and is defined as (Indraratna et al., 2014a, 2010b, Tennakoon et al., 2012). As shown in Fig. 1(b), *VCI* can capture the amount of fouling more accurately compared to other mass based indices, because later do not consider the correct volume of fouling in a real track environment.

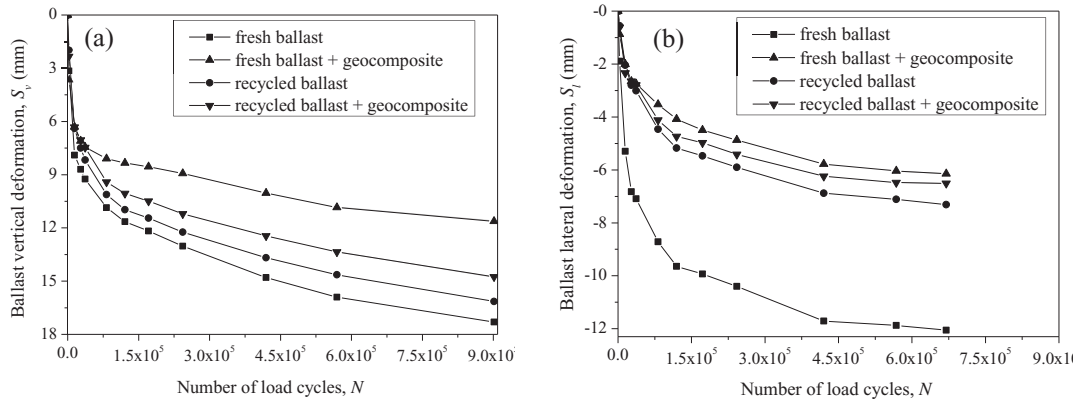
**Figure 2:** Average deformations of the ballast layer: (a) vertical ( $S_v$ ); (b) lateral ( $S_l$ ) (data sourced from Indraratna et al., 2010a).

The deformation of ballast was determined by subtracting the settlement of the ballast-capping interface from that at the sleeper-ballast interface. Figure 2 shows the variation of average deformations for both fresh and recycled ballast against the number of load cycles ( $N$ ). The results indicate that both fresh and recycled ballast showed increased deformations as number of load cycles increased. Compared to fresh ballast, the recycled ballast exhibited less vertical and lateral deformations. This could be attributed to its moderately graded PSD ( $C_u = 1.8$ ) compared to the very uniform PSD ( $C_u = 1.5$ ) of fresh ballast. Aggregates of recycled ballast underwent less breakage because they were less angular. This in turn prevented corner breakage resulting from high contact stresses. The results also indicate that geocomposite reinforcement reduced vertical ( $S_v$ ) and lateral ( $S_l$ ) deformation of fresh ballast by 33 % and 49 % respectively (Figs. 2a, 2b). It also reduced vertical ( $S_v$ ) and lateral ( $S_l$ ) deformation of recycled ballast by 9 % and 11 % respectively (Figs. 2a, 2b). Lateral deformation is one of the most important indices and the geocomposite reinforcement was able to curtail it effectively, resulting into much improved lateral stability.

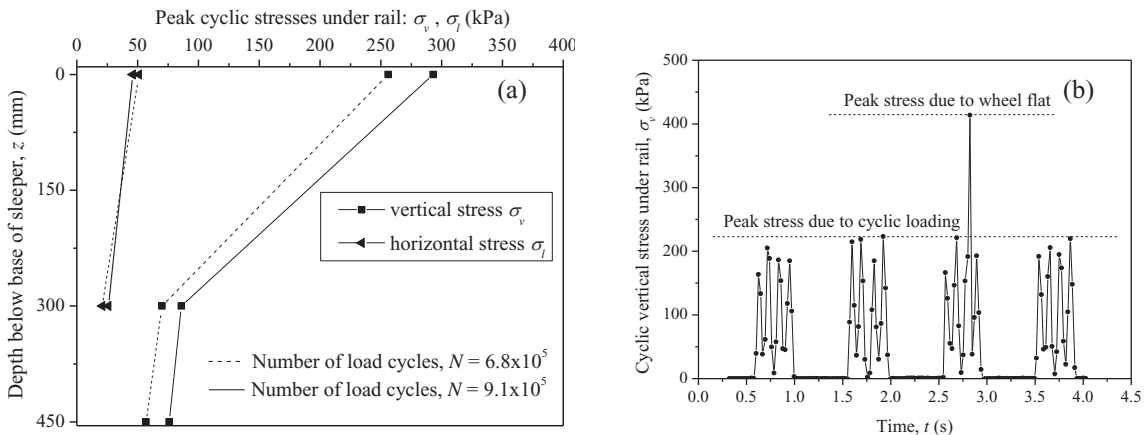
**Figure 3:** Cyclic stresses induced by coal train with wagons (100 tons): (a) variation of stresses with depth, (b) additional stress due to wheel flat (data sourced from Indraratna et al., 2010a).

Figure 3(a) shows the peak cyclic vertical ( $\sigma_v$ ) and lateral ( $\sigma_l$ ) stresses recorded at Section 1 (i.e. fresh ballast without geocomposite) due to the passage of a coal train with an axle load of 25 tons. The stresses were measured under the rail. The peak cyclic vertical stress ( $\sigma_v$ ) was reduced by 73 % and 82 % at the depth of 300 mm and 450 mm, respectively. It was also evident that  $\sigma_l$  decreased only marginally with depth, thus implying the need of artificial inclusions for additional restraints. Due to time constraints and funding limitations, pressure cells were not installed at multiple locations elsewhere, thus rendering difficulty in direct comparison across these Sections.

While most of the peak cyclic vertical stresses ( $\sigma_v$ ) were up to 230 kPa, one value of  $\sigma_v$ , which was later found to be associated with a wheel flat, reached 415 kPa. This proved that much larger stresses are exerted by wheel imperfections. The resulting particle breakage could be mitigated by shock mat as discussed in Singleton study.

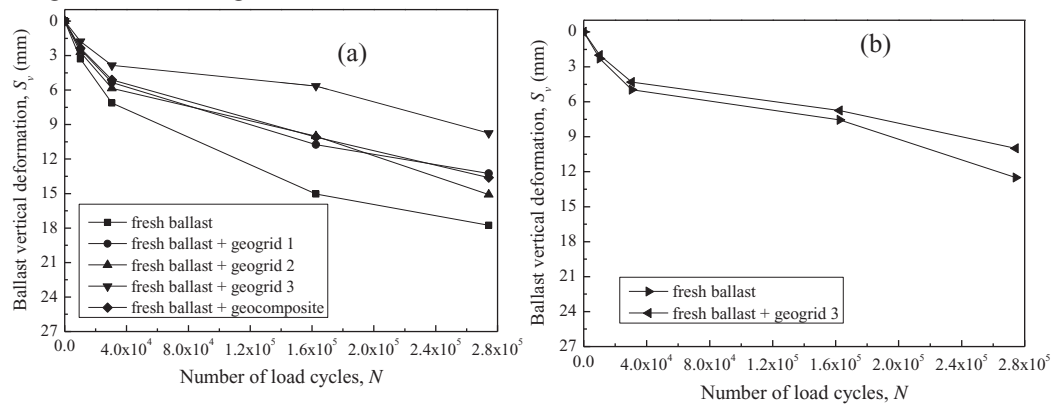
**Figure 4:** Vertical deformation of ballast for (a) soft embankment; (b) hard rock (data sourced from Indraratna et al., 2014d)

The vertical deformation ( $S_v$ ) of the ballast is plotted against number of load cycles ( $N$ ) in Fig. 4(a) and 4(b) for soft embankment and hard rock, respectively. These results indicated that the relationship between  $S_v$  and  $N$  was non-linear for all Sections. The rate of increase of  $S_v$  diminished as the number of load cycles increased.  $S_v$  of the reinforced sections were 10-32% smaller than those without reinforcement. This pattern was similar to that observed in the laboratory (Indraratna et al., 2012, Indraratna and Nimbalkar, 2013), and it could be attributed mainly to particle-grid interlock. The

results also indicated that  $S_v$  were larger when the subgrade becomes weaker. It was apparent that the geogrid reinforcement was much effective to reduce deformations of track located on softer subgrades.
